**Route Summary Report
Sough Lane
March 2015**

Description

Sough Lane commences at Moor Lane, east of Chelmorton heading generally northwards before descending generally north east to the A6 west of Taddington. Route shared with the Limestone Way.

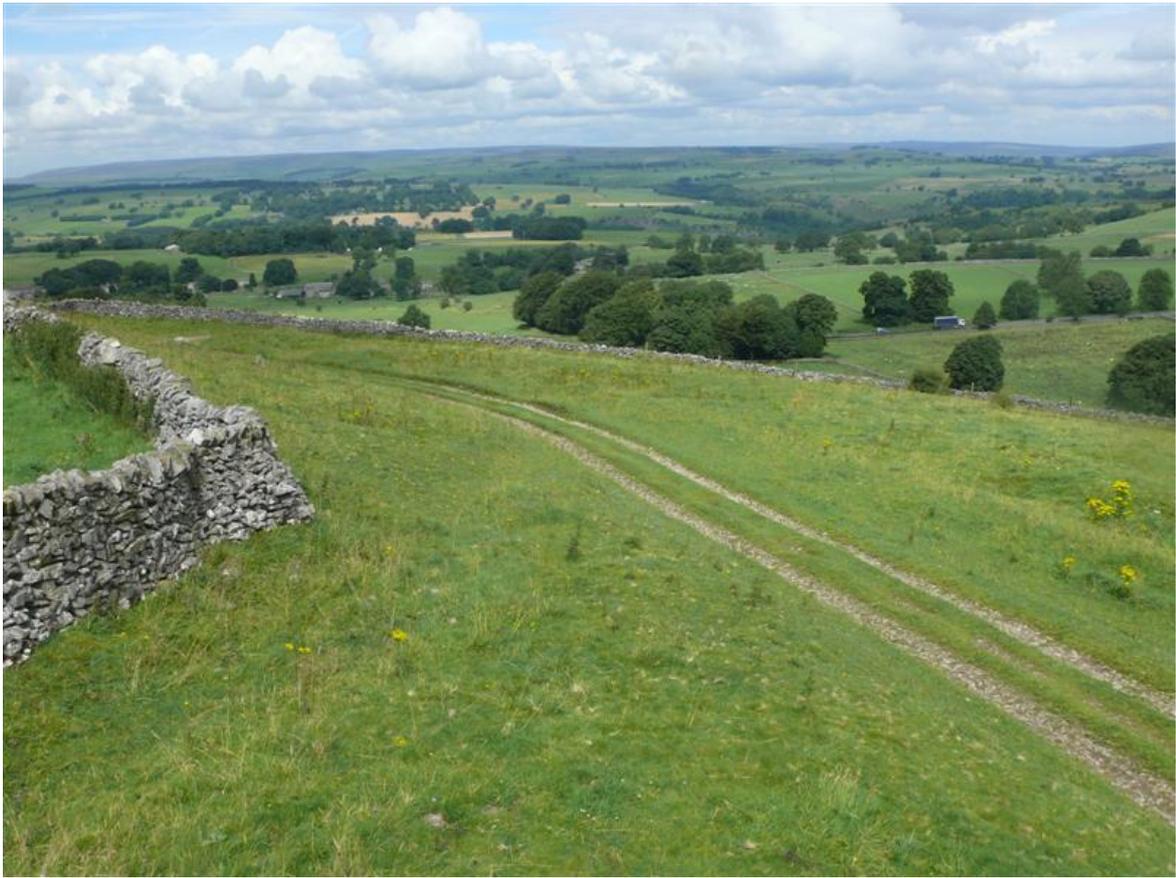
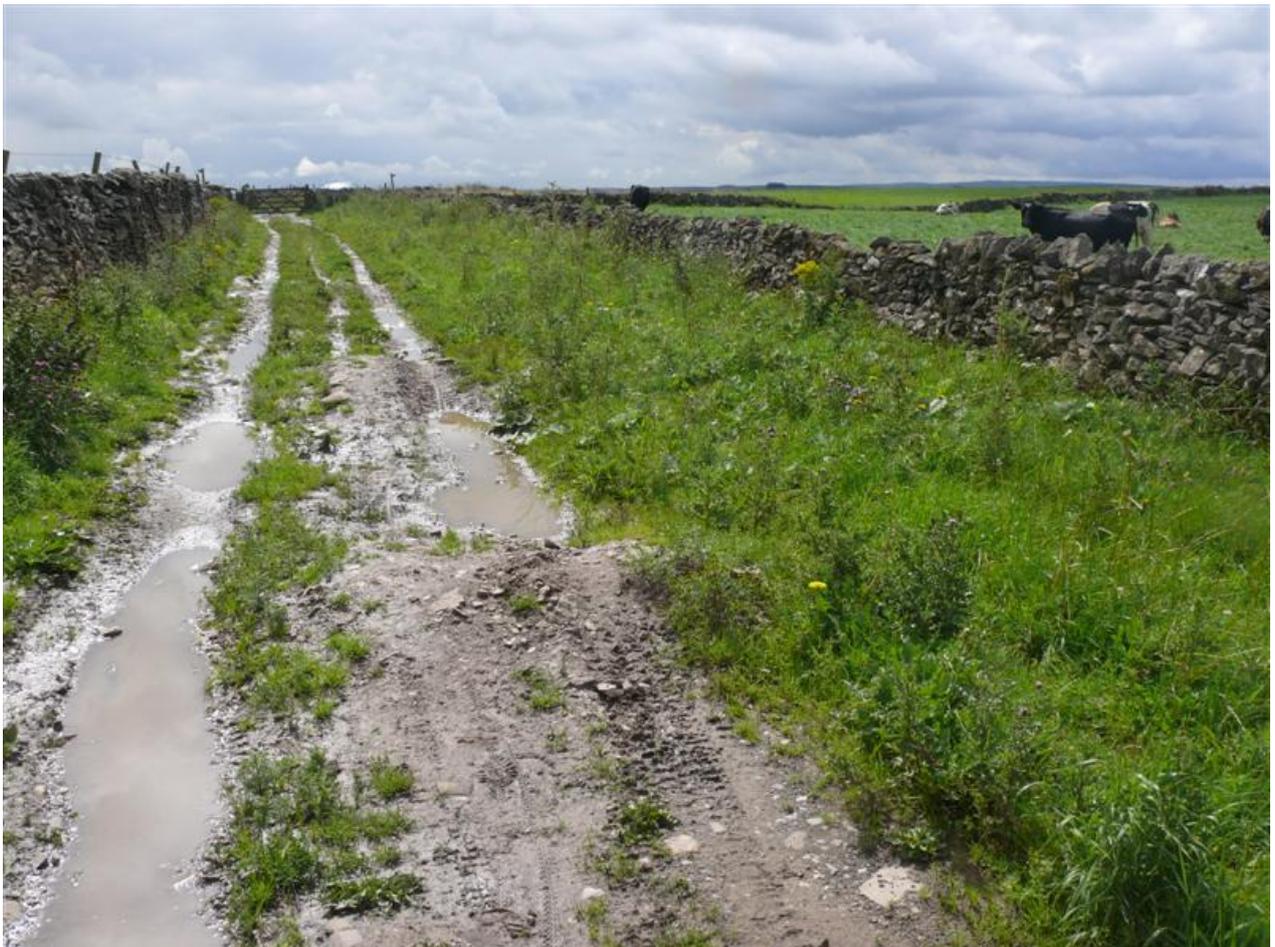
Comment: Central section has drainage and surface issues

Comments: Central section badly rutted

Comments: Central section is difficult to use in wet weather.

- Resurface and drainage on bad section – but maintain the character of the steeper section
- Signage needs improving to reflect the route's importance as Limestone Way
- Monitor use and verge flora
