**Project Name:** Trentabank Quiet Lane Macclesfield Forest 120224  
**Project Description:** WinCan Import in Miraculix Standard  
**Project Status:** Complete  
**Project Date:** 16/02/2024

**Company:** Peak District National Park Authority  
**Contact:** Matt Freestone  
**Department:** Aldern House  
**Street:** Baslow Road  
**Town or City:** Bakewell  
**County:** Derbyshire

**Company:** County Drains Ltd  
**Contact:** Elspeth Holliday  
**Department:** Newstead  
**Street:** 49 Burlow Road  
**Town or City:** Buxton  
**County:** Derbyshire  
**Post Code:** SK17 9HY

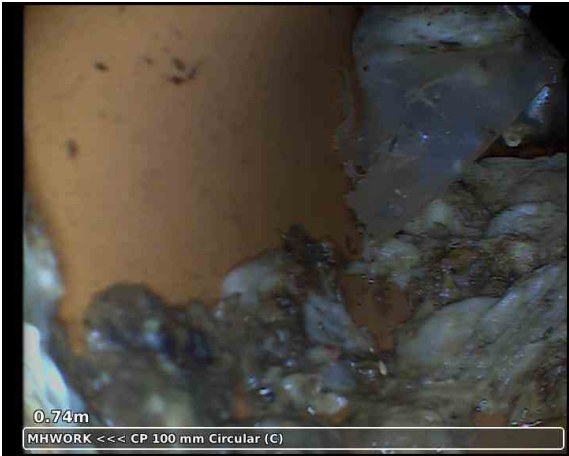
20240211-234448-snap0001.jpg, 00:00:13, 0.74 m

| Scale: | 1:50 | Position [m] | Code | Observation | MPEG | Photo | Grade |
|---|---|---|---|---|---|---|---|
| | | 0.74 | SA | Survey abandoned: Capped Off | 00:00:13 | 20240211-234448-sn ap0001.jpg | |

Survey abandoned, Capped Off

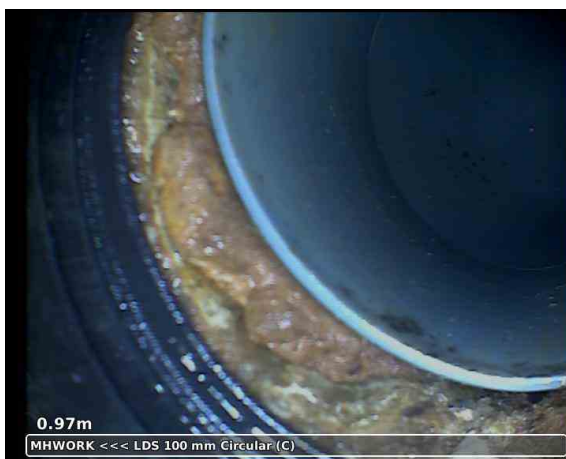
| Scale: | 1:50 | Position [m] | Code | Observation | MPEG | Photo | Grade |
|---|---|---|---|---|---|---|---|
| | | 0.97 | SA | Survey abandoned: Rest Bend - Disabled WC and Ladies | 00:00:23 | 20240211-234549-sn ap0002.jpg | |

20240211-234549-snap0002.jpg, 00:00:23, 0.97 m  
Survey abandoned, Rest Bend - Disabled WC and Ladies

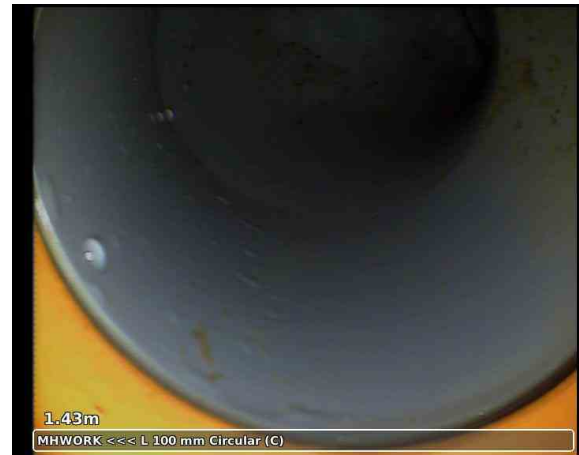
| Scale: | 1:50 | Position [m] | Code | Observation | MPEG | Photo | Grade |
|---|---|---|---|---|---|---|---|
| | | 1.43 | SA | Survey abandoned: Rest Bend Ladies | 00:00:16 | 20240211-234716-sn ap0001.jpg | |

20240211-234716-snap0001.jpg, 00:00:16, 1.43 m  
Survey abandoned, Rest Bend Ladies

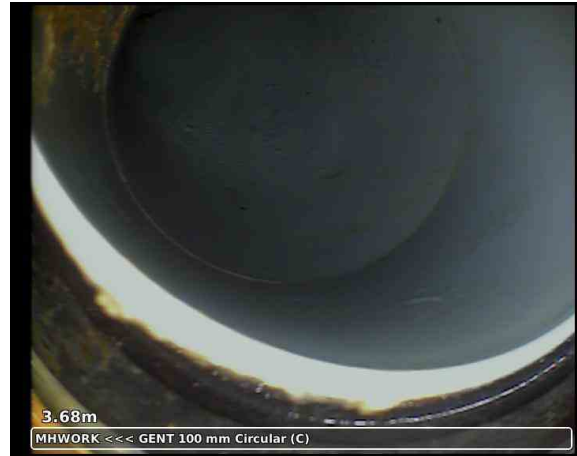
Survey abandoned: Rest Bend Gents

20240211-234826-snap0001.jpg, 00:00:23, 3.68 m  
 Survey abandoned, Rest Bend Gents

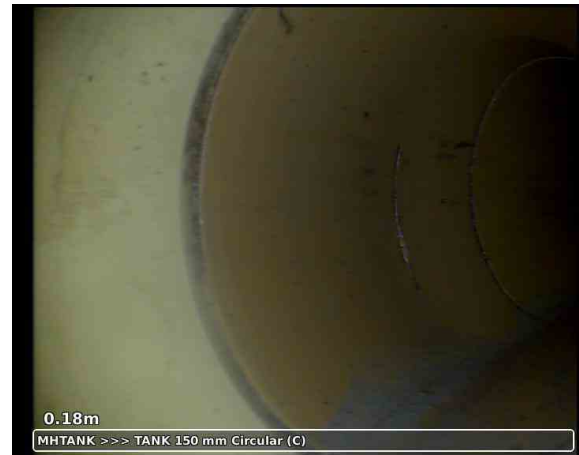
20240212-002705-snap0001.jpg, 00:00:24, 0.18 m  
Pipe size changes, new size(s), 100mm high
