Management & Specified Refurbishment Asbestos Survey of

Trentabank Visitor Centre, In Macclesfield Forest, Macclesfield, Cheshire, SK11 0NS

Position: Project Manager	Issue Date: 14/01/2025
Project Number: P-51584	Client Reference: NA
Report Modification	NA

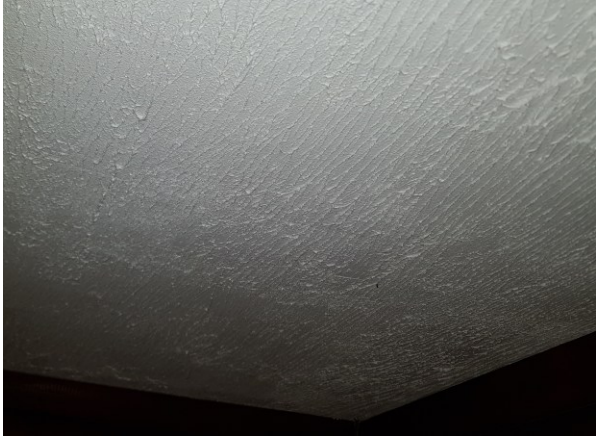
Room/Area: Floor 0, Room 001 (Meeting Room)
	Description: Decorative coating to the ceiling (Textured coating) - P-51584-01
	Sample Identifier: P-51584-01
	Result: AND - Asbestos Not Detected.
	Notes:
Recommendations: Upon analysis, no asbestos fibres were detected

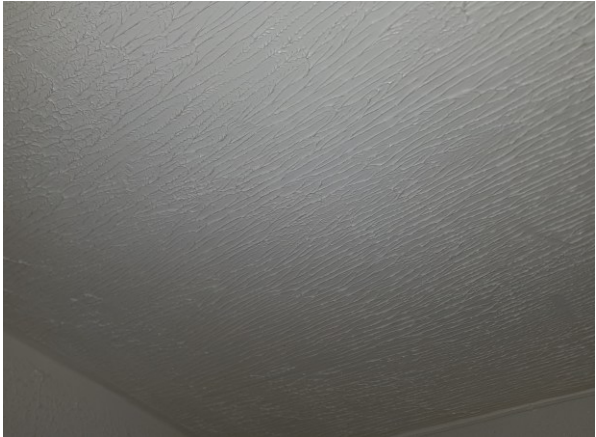
Room/Area: Floor 0, Room 002 (Kitchen)
	Description: Decorative coating to the ceiling (Textured coating) - P-51584-01
	Sample Identifier: P-51584-01
	Result: AND - Asbestos Not Detected.
	Notes:
Recommendations: Upon analysis, no asbestos fibres were detected

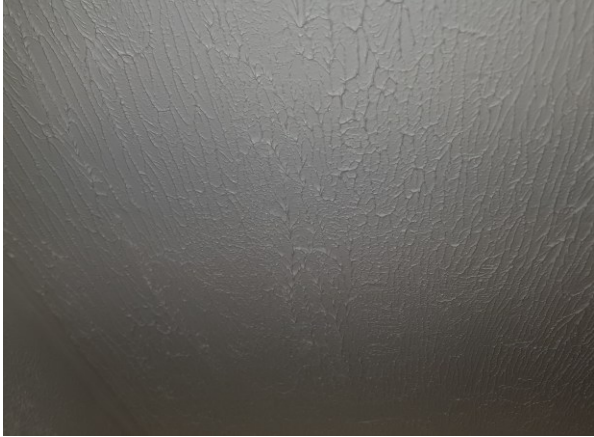
Room/Area: Floor 0, Room 003 (Office)
	Description: Decorative coating to the ceiling (Textured coating) - P-51584-01
	Sample Identifier: P-51584-01
	Result: AND - Asbestos Not Detected.
	Notes:
Recommendations: Upon analysis, no asbestos fibres were detected

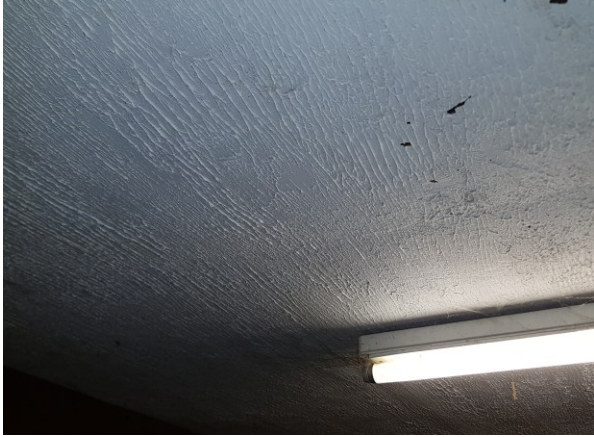
Room/Area: Floor 0, Room 004 (Workshop)
	Description: Decorative coating to the ceiling (Textured coating) - P-51584-01
	Sample Identifier: P-51584-01
	Result: AND - Asbestos Not Detected.
	Notes:
Recommendations: Upon analysis, no asbestos fibres were detected

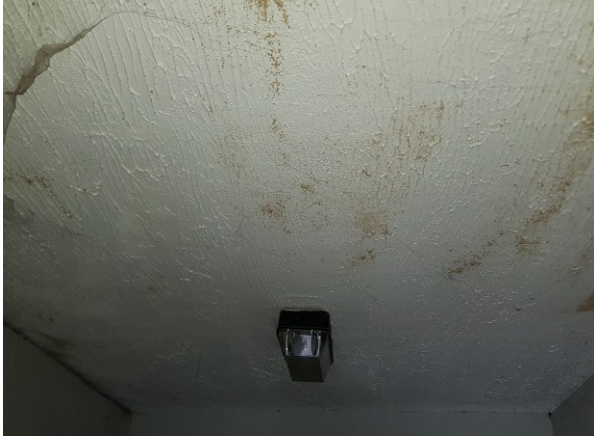
Room/Area: Floor 0, Room 007 (Ladies toilet)
	Description: Decorative coating to the ceiling (Textured coating) - P-51584-01
	Sample Identifier: P-51584-01
	Result: AND - Asbestos Not Detected.
	Notes:
	Recommendations: Upon analysis, no asbestos fibres were detected

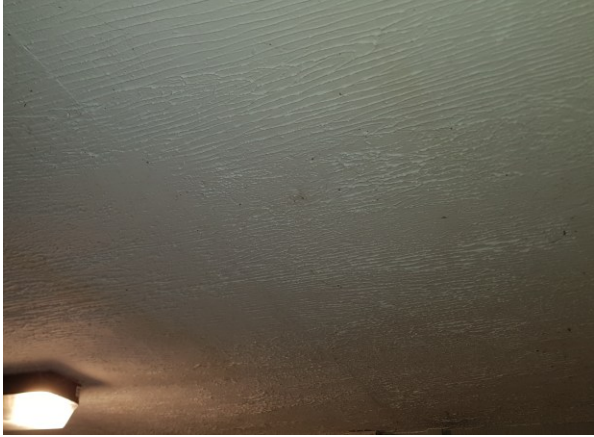
Room/Area: Floor 0, Room 008 (Gents toilet)
	Description: Decorative coating to the ceiling (Textured coating) - P-51584-01
	Sample Identifier: P-51584-01
	Result: AND - Asbestos Not Detected.
	Notes:
	Recommendations: Upon analysis, no asbestos fibres were detected

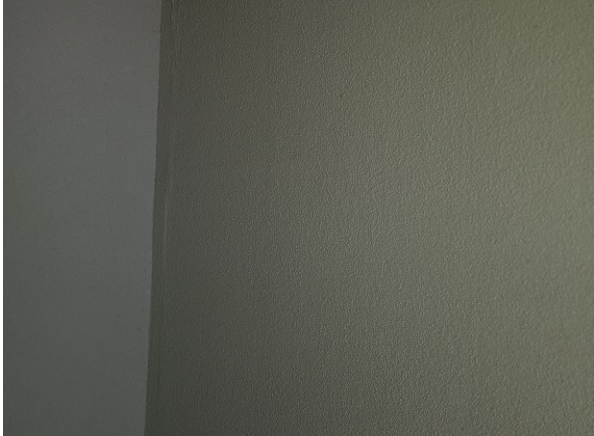
Room/Area: Floor 0, Room 006 (Disabled Toilet)
	Description: Decorative coating to the walls (Textured coating) - P-51584-05
	Sample Identifier: P-51584-05
	Result: AND - Asbestos Not Detected.
	Notes:
	Recommendations: Upon analysis, no asbestos fibres were detected

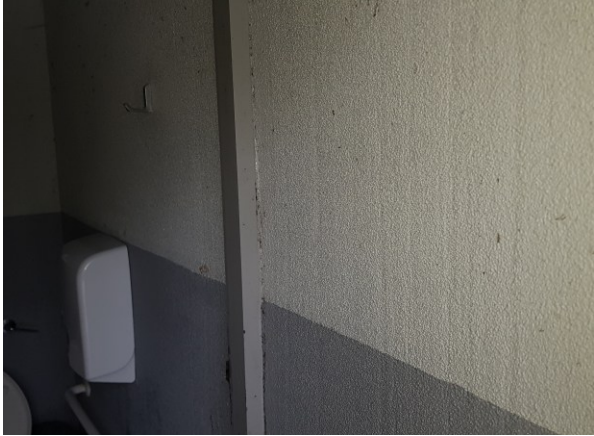
Room/Area: Floor 0, Room 007 (Ladies toilet)
	Description: Decorative coating to the walls (Textured coating) - P-51584-05
	Sample Identifier: P-51584-05
	Result: AND - Asbestos Not Detected.
	Notes:
	Recommendations: Upon analysis, no asbestos fibres were detected

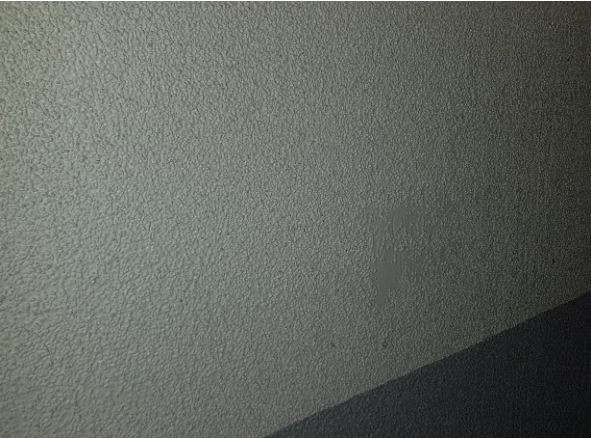
Room/Area: Floor 0, Room 008 (Gents toilet)
	Description: Decorative coating to the walls (Textured coating) - P-51584-05
	Sample Identifier: P-51584-05
	Result: AND - Asbestos Not Detected.
	Notes:
	Recommendations: Upon analysis, no asbestos fibres were detected

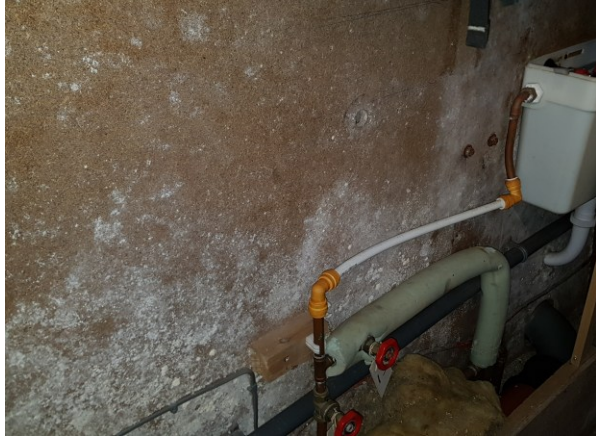
Room/Area: 004 Workshop

Notes: This photograph shows the intrusive inspection within the timber boxing revealing plastic toilet cisterns and plastic pipework. No suspected asbestos containing materials were identified.

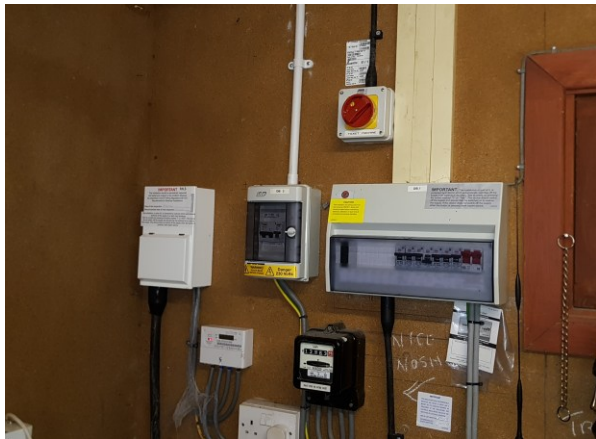
Room/Area: 004 Workshop

Notes: This photograph shows the modern electric fuse board and meter fixed to timber back boards. No suspected asbestos containing materials were identified.

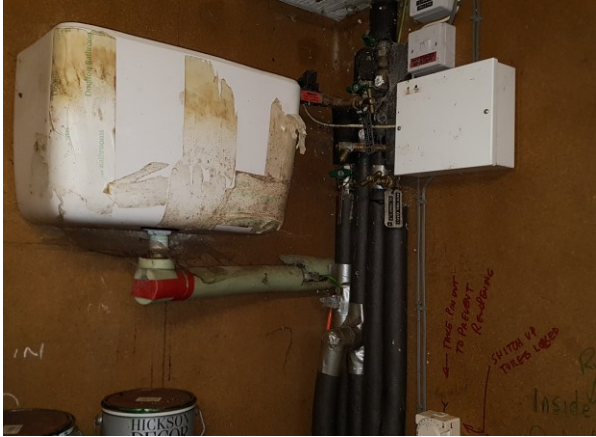
<p>Room/Area: 004 Workshop</p> <p>Notes: This photograph shows the modern foam lagged copper pipework. No suspected asbestos containing materials were identified.</p>

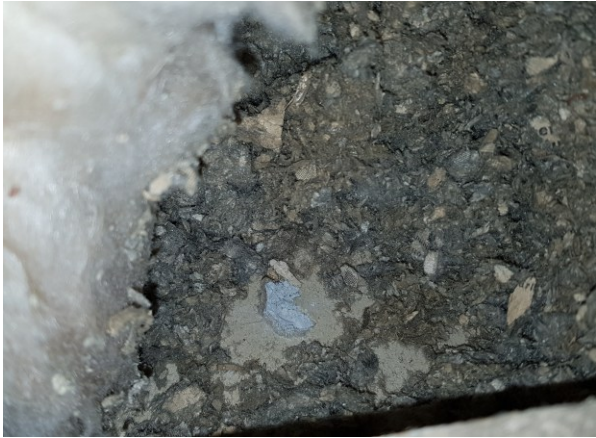
<p>Room/Area: 005 Roof Void</p> <p>Notes: This photograph shows the plasterboard ceiling below the MMMF and modern loose fill insulation. No suspected asbestos containing materials were identified.</p>

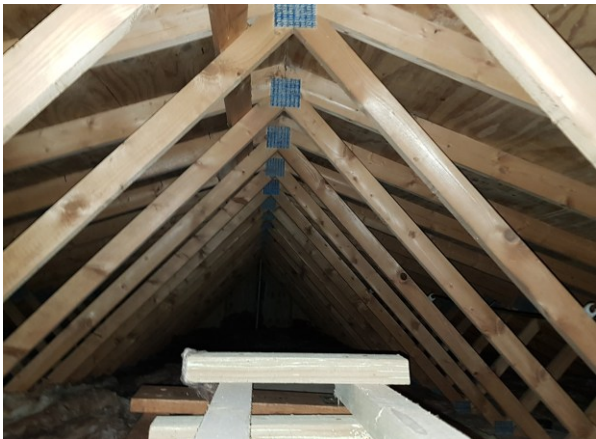
Room/Area: 005 Roof Void

Notes: This photograph shows the general view of the roof void. No suspected asbestos containing materials were identified.
