School Lane

Route Management Plan

School Lane - Route Management Plan

School Lane (New Hedge Lane)

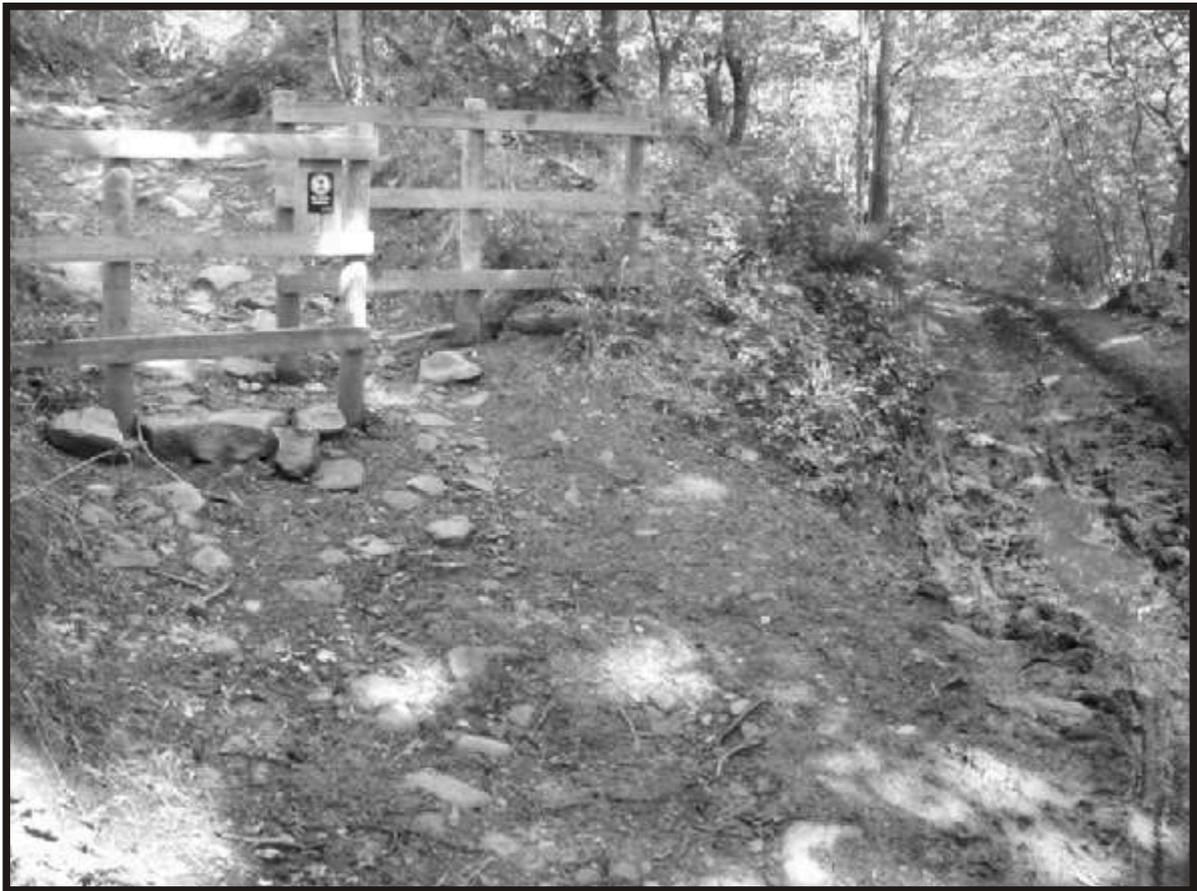
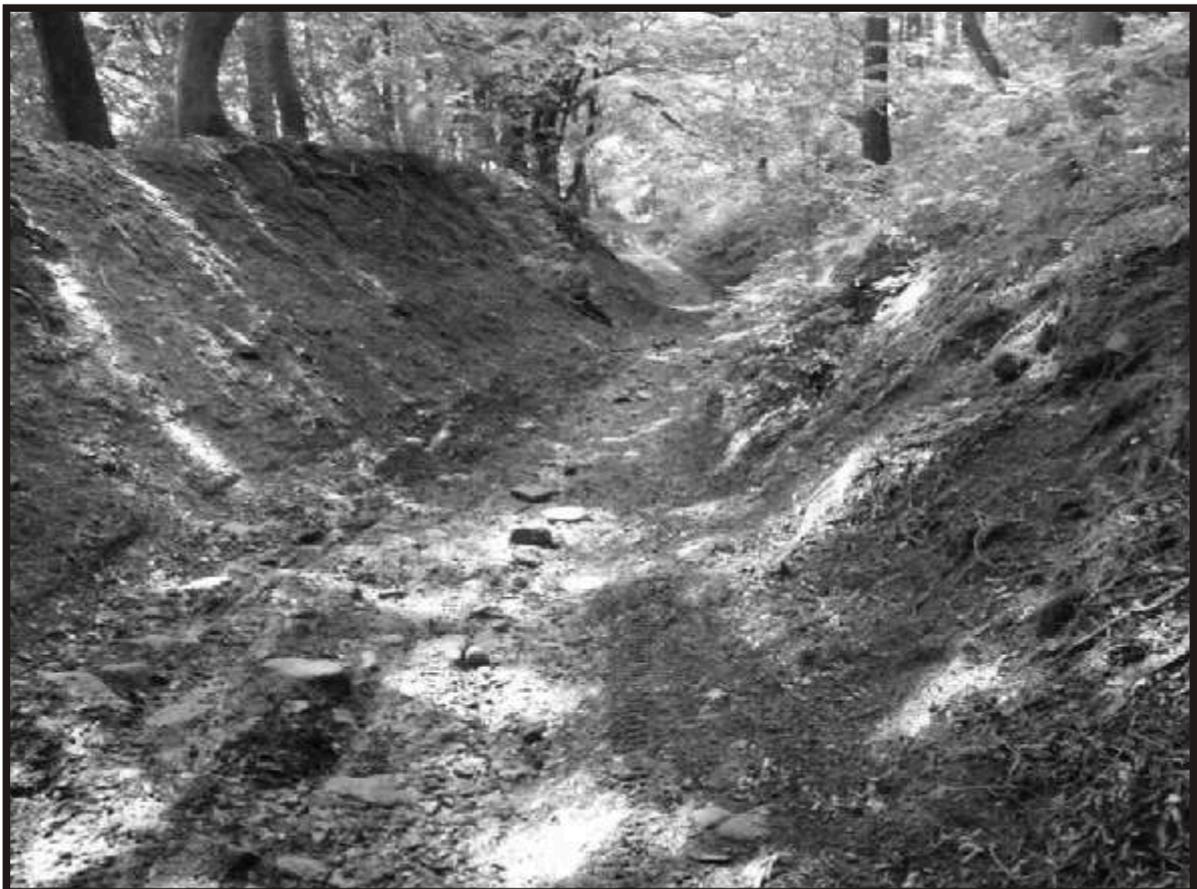
School Lane

The lane commences in Main Road, Great Hucklow and proceeds generally northwards, then eastwards to Hucklow Edge.

There is a claimed Byway at Foolow about 500 metres to the east. To the west, a claimed Byway exists 100 metres from this lane, southwards is the track at Silly Dale.

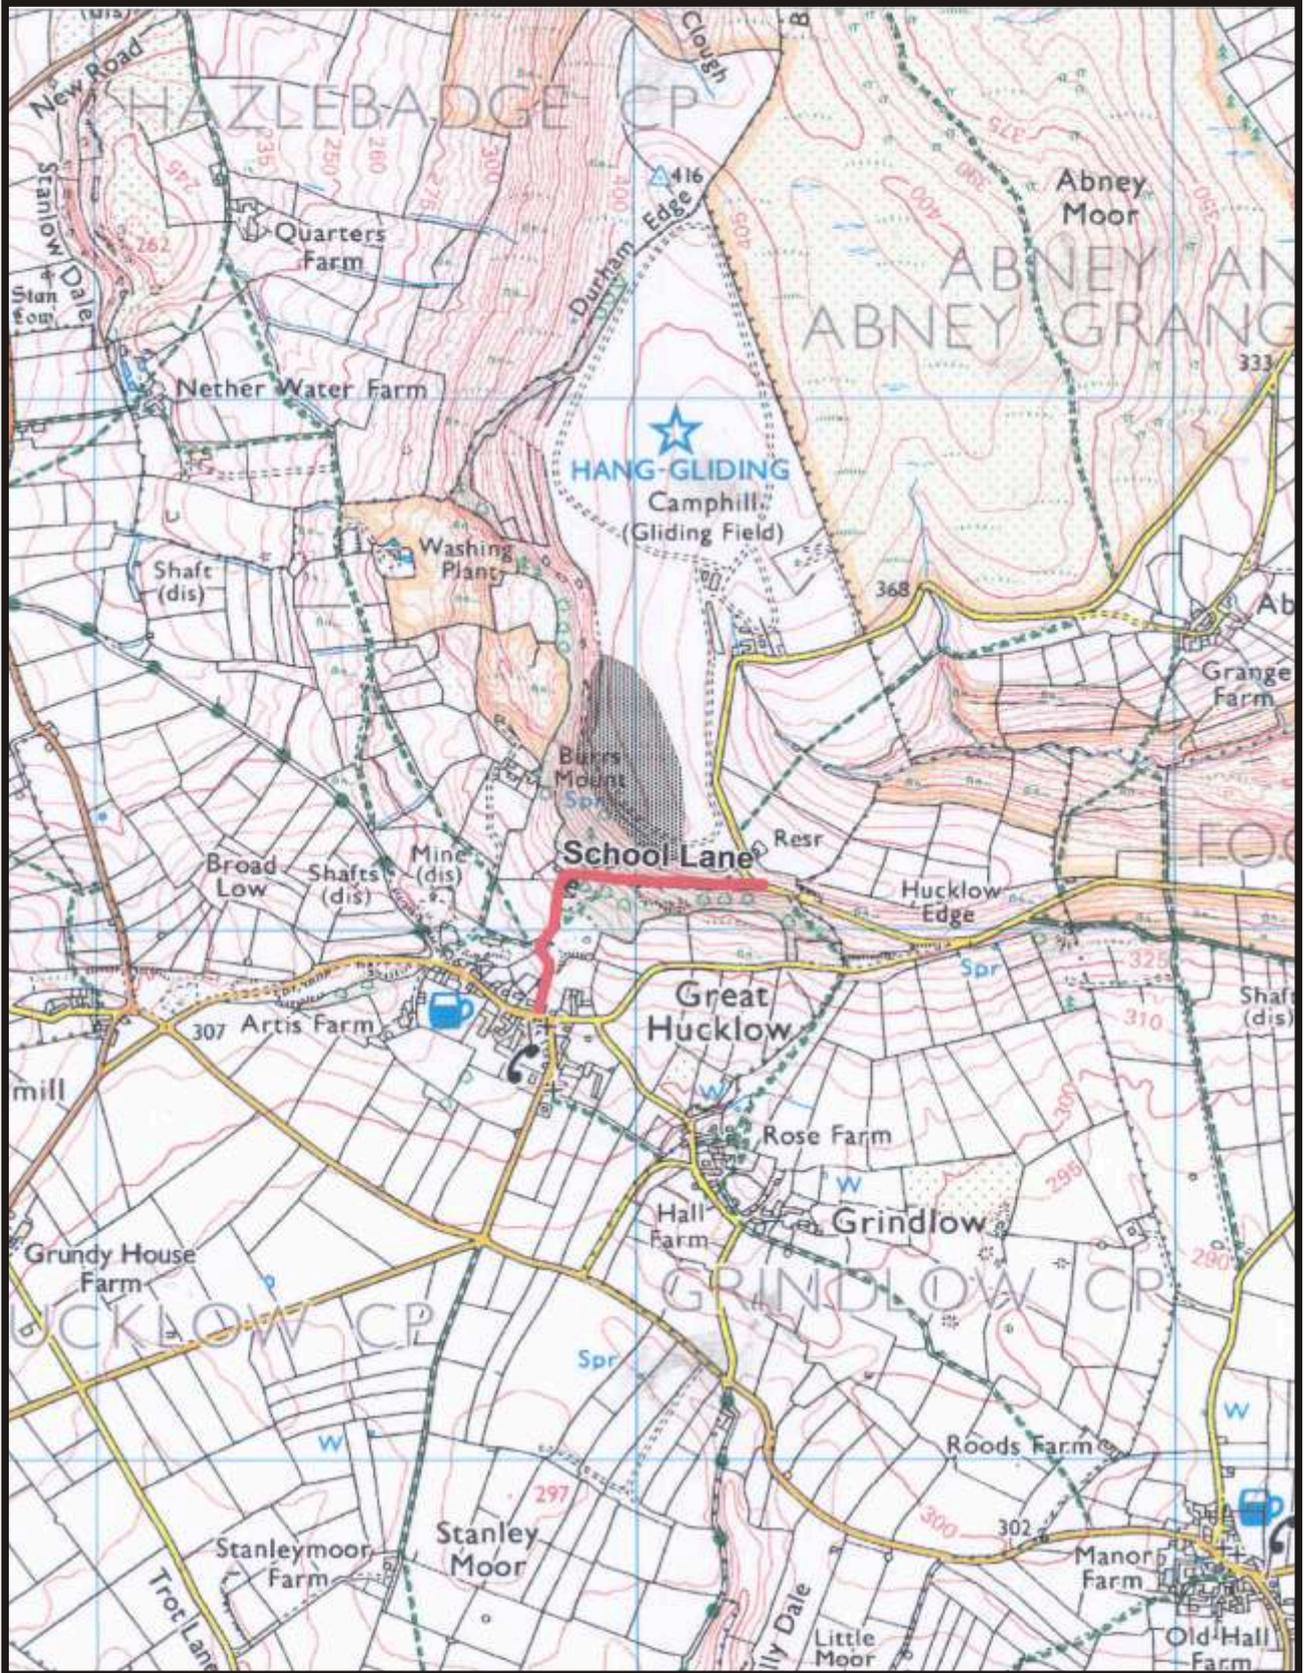
Map illustrating cultural heritage features on or close to the route

Please see annotated map on next page illustrating detailed information on cultural heritage features on or close to the route.

Historic landscape character information: the northern section of the route runs through an area which is characterised as Managed Plantations/Woodland. This stretch of woodland was present by 1849 (Great Hucklow Tithe Map).

To the north of Great Hucklow the route runs through an area which is characterised as Industrial. This area was part of a much larger enclosed area with no internal boundaries in 1631 (Senior Map), marked as Great Hucklow Pasture. Enclosure boundaries date from after 1631 and before the 1803 Great Hucklow Enclosure Map. Lead mines are marked here on the 1880 1st ed. 25" OS map.

As the route enters Great Hucklow it runs through an area characterised as Ancient Enclosure - Irregular Fields (not on strip fields) which was enclosed prior to 1631.
