Conservation Area Appraisal

April 2008

Litton

LITTON CONSERVATION AREA APPRAISAL

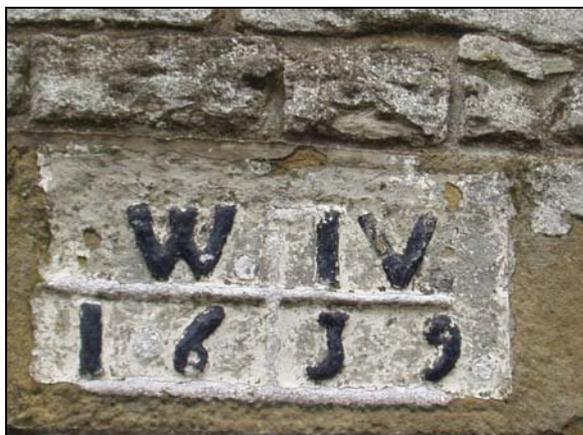
P19 Date stone at West Cottage

appears to contain some very early features. It has a lintel bearing the date 1639 over a window (formerly a doorway) and to the right of this are the remains of a chamfered mullioned window indicating that some seventeenth century building fabric remains in Litton. The Methodist Church, opened in 1834, is said to be a converted seventeenth century farmhouse.

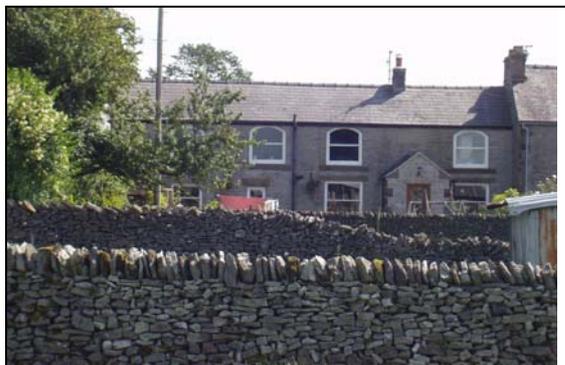
P22 West Villas with surviving sash windows

simple two storey buildings without the quoins or coped gables found on earlier buildings. The size of window openings, which are comparatively large with a vertical emphasis, also indicate a nineteenth century date. Presumably most of these openings contained sash windows, but few originals survive. Although there are some modern replicas the majority of windows are twentieth century designs.

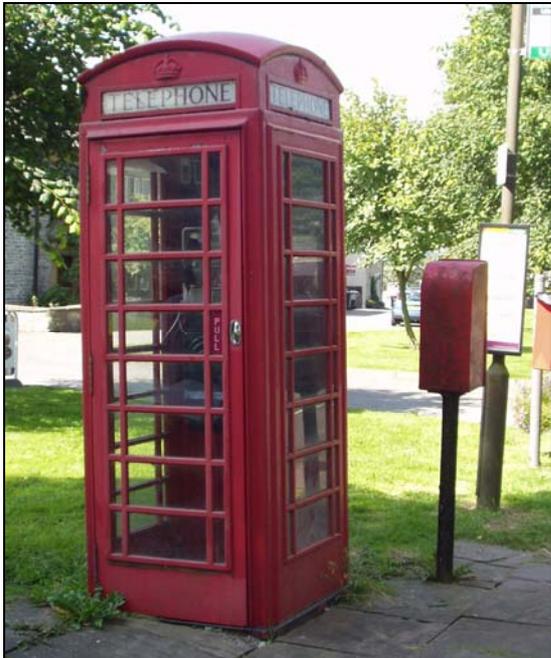
P26 Historic K6 Phone box

5.14 There is an unlisted K6 phonebox on the green in front of Post Office Row.

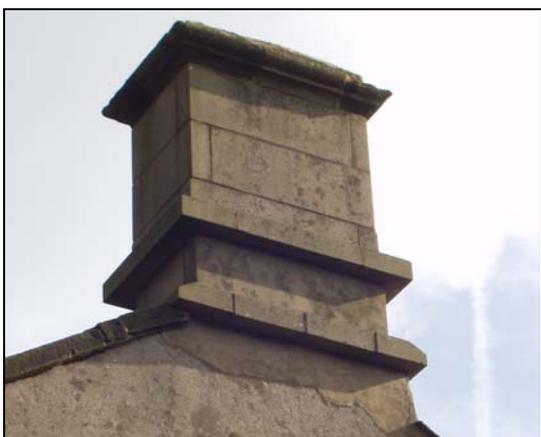
P27 Ashlar chimney

6.2 Stone chimneys are a common feature and on older and high status properties these are often ashlar with decorative drip moulds. Both gritstone and limestone chimneys are found.

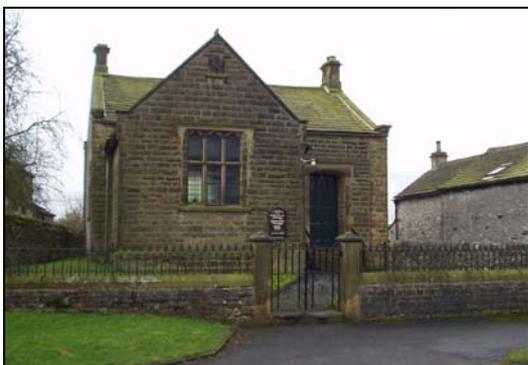
P28 The Methodist Chapel built of gritstone

6.4 Limestone is the pre-dominant building material in the village. There are three gritstone buildings in Litton, the two churches and the eighteenth century addition to Hammerton Hall Farmhouse. In the case of the Methodist Church, the front elevation is gritstone, and the rest of the building is rendered.

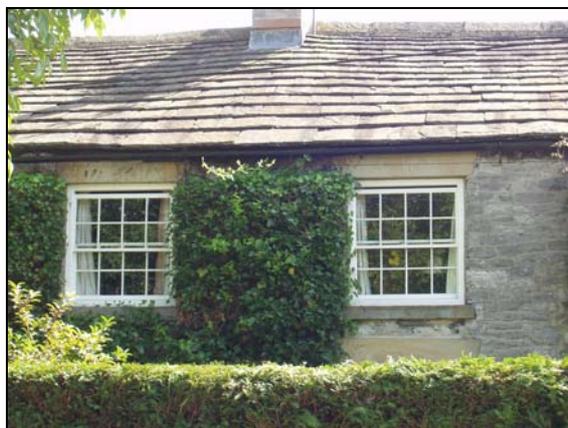
P29 Sash windows with stone heads and cills

6.5 Gritstone is commonly used for stone dressings. Earlier buildings have full gritstone window surrounds, later ones just have gritstone heads and cills.

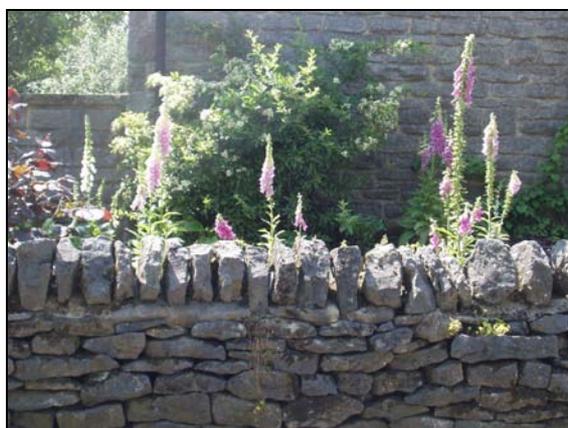
P30 Typical garden boundary wall

6.8 Boundary walls are usually limestone rubble construction. Both drystone and mortared walls are found. Coping stones are usually gritstone and a variety of details are found including rounded, flat and triangular. Those on the boundary wall at Clergy House are particularly decorative indicating the status of this building.

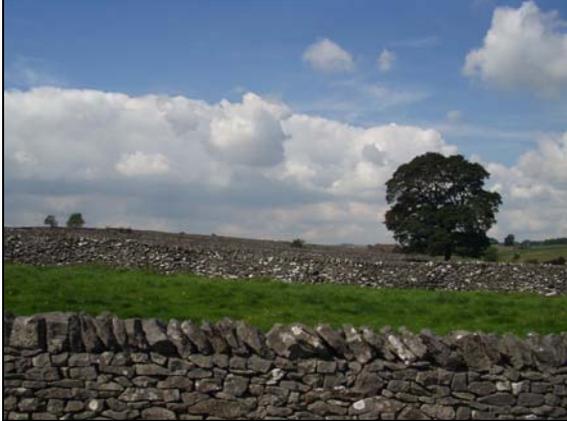
P31 Drystone walls from Hall Lane

6.9 The village is surrounded by strip fields bounded by dry limestone walls. These are a key feature of the Conservation Area and are particularly noticeable to the south of the village.

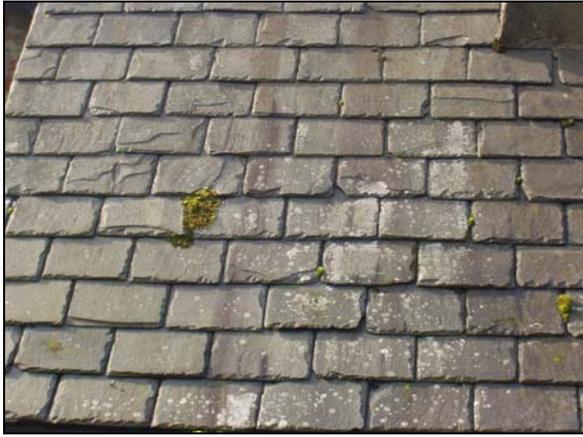
P33 Blue slate roof

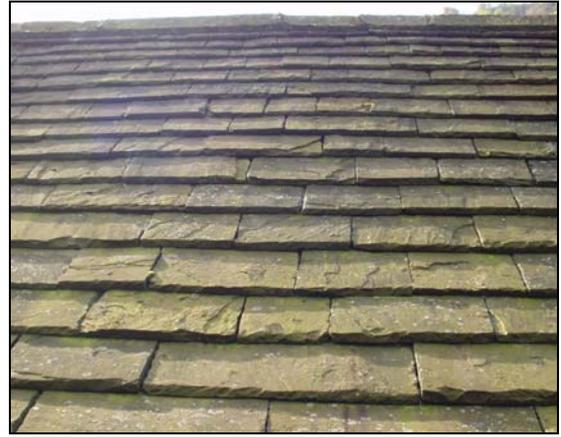
P34 Stone slate roof

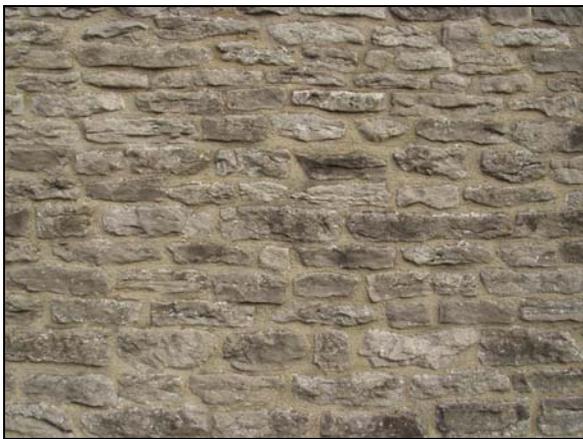
P35 Limestone rubble brought to courses.

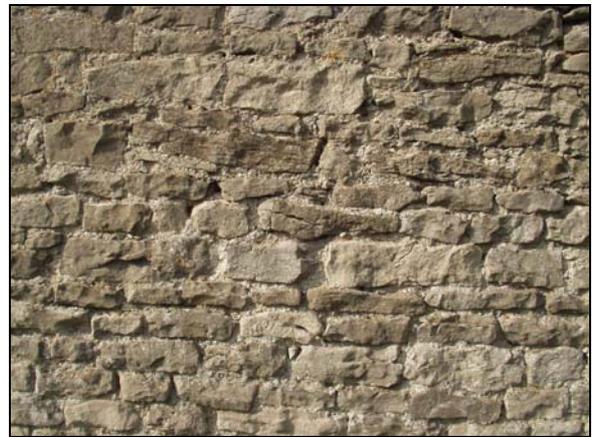
P36 Limestone rubble wall.

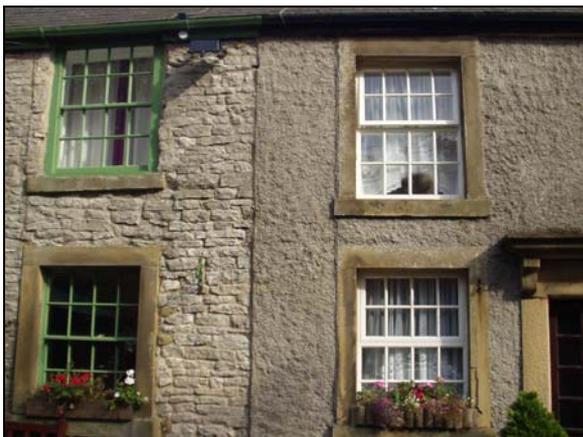
P37 Limestone wall and rendered wall with gritstone dressings.

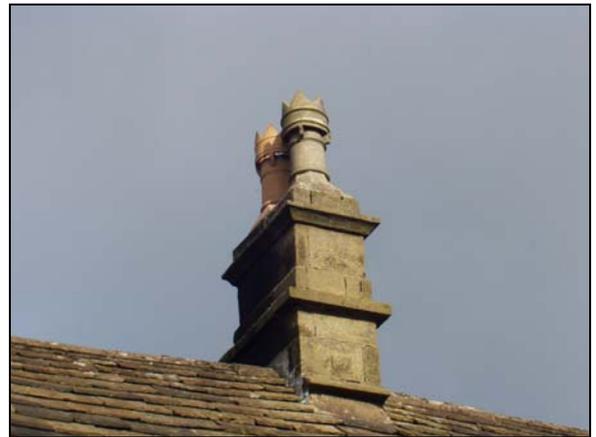
P38 Gritstone chimney on a stone slate roof.

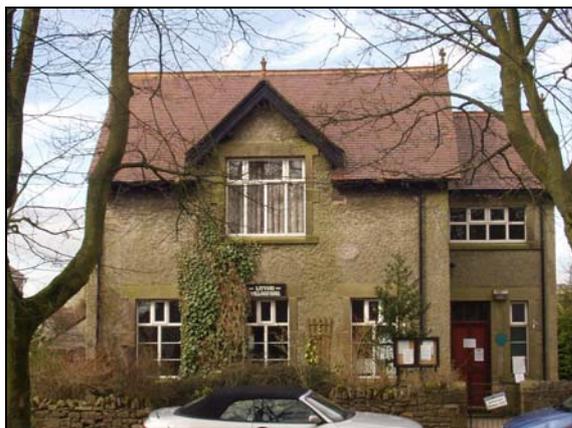
P55 Red clay tile, as used on the Village Hall, is not a traditional material
