5.0 ARCHITECTURAL AND HISTORIC QUALITIES

6.0 PREVALENT AND TRADITIONAL BUILDING MATERIAL

7.0 THE RELATIONSHIP OF STRUCTURES AND SPACES

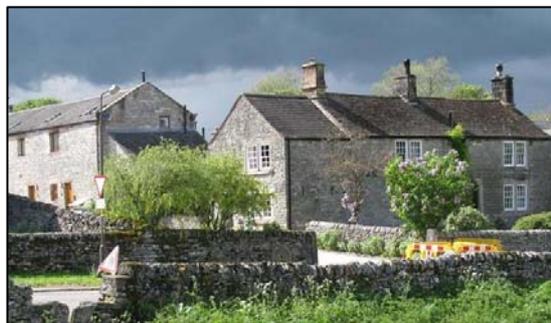
P5.2 Agricultural buildings located to the rear of Mere Farmhouse.

5.7 Monyash originated as an agricultural settlement and many of the buildings within the Conservation Area were originally farmhouses, with associated barns and other outbuildings. As a result, many buildings still retain a barn-like appearance, with large cart entrances and few openings, even where these farm buildings have been converted to residential use. A characteristic feature of the Conservation Area is that most of the agricultural buildings are located immediately to the rear of the main farmhouse, at ninety degrees to the road; this may be due to the physical constraints of the fossilised medieval strip field boundaries.

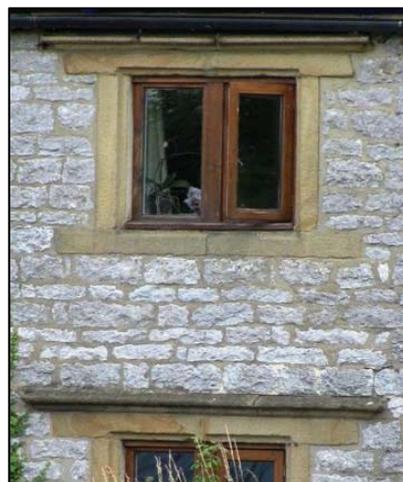
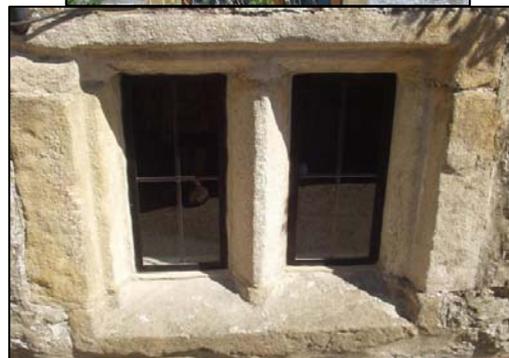
P5.3 Seventeenth century double-chamfered windows at Mount Pleasant (top); 1 Old Hall Cottages (bottom)

5.16 Mount Pleasant has double-chamfered, mullioned windows with hood moulds above the lintels to its front elevation, although the mullions are no longer in situ. These features suggest that the building has seventeenth century origins. The building would have been located on what was once one of the main routes into the settlement and is an important unlisted building within the Conservation Area.

5.17 Old Hall Cottages are listed (Grade II) as being early nineteenth century in date. However, there are seventeenth century chamfered mullioned windows to the side elevation of number 1, with hood moulds over a number of the windows even where openings have been enlarged and later sash windows inserted. This suggests that the western end of the terrace may have incorporated part of an older, seventeenth century building, perhaps the 'Hall' marked on the 1840 Ordnance Survey Map in the location of Old Hall Cottages.

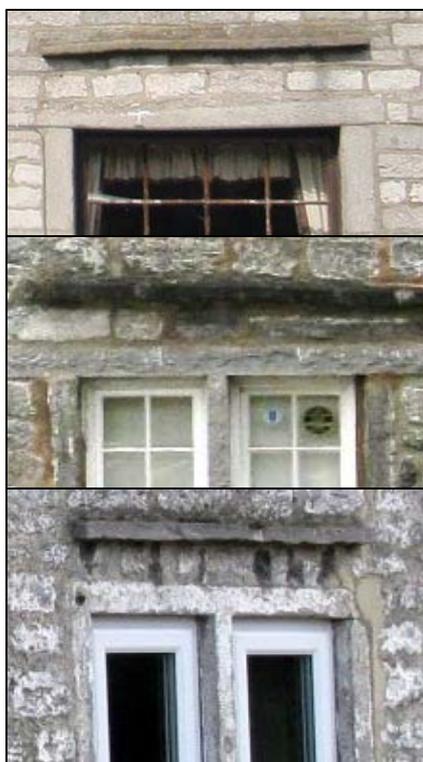
P5.4 From top to bottom: eighteenth century horizontal stone hood moulds at the Bull's Head, school and Shepley House

5.19 The eighteenth century frontage to the Bull's Head has a horizontal stone hood mould above each of its windows, even though most of the window openings to this elevation have been altered. A similar hood mould detail can be seen on the eighteenth century building at the west end of the school and on the west elevation of Shepley House, at the south-eastern corner of Chapel Street. Shepley House has flush window surrounds to this elevation, suggesting that it may also be of a similar, eighteenth century date.

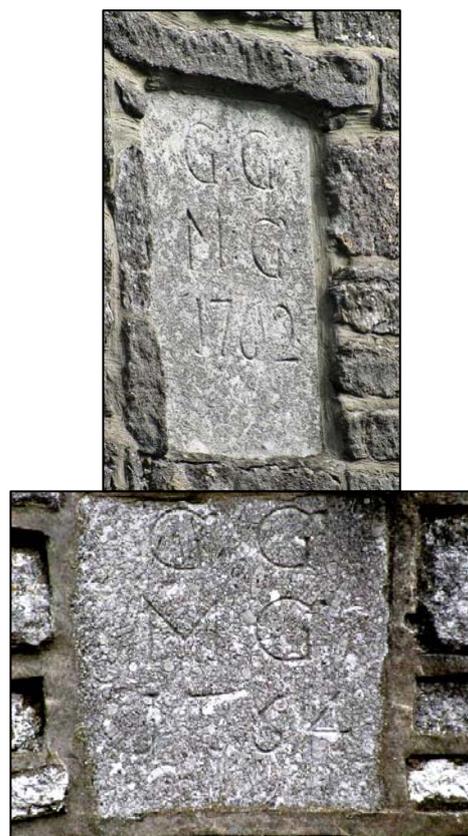
P5.5 Datestones at 1 Dale View Cottages (top) and Oakdene (bottom)

5.22 1 Dale View Cottages and Oakdene on Chapel Street both have a very similar datestone, the former of 1762, the latter of 1764. Both have the initials 'GG' and 'MG' inscribed alongside the date, indicating that they were constructed at around the same time by, or for, the same person or people. The datestone for Dale View Cottages is consistent with the eighteenth century window surrounds on the same, south-facing elevation: it is likely that this was the original front of the property, which was then remodelled in the nineteenth century at which time the north elevation became the front.

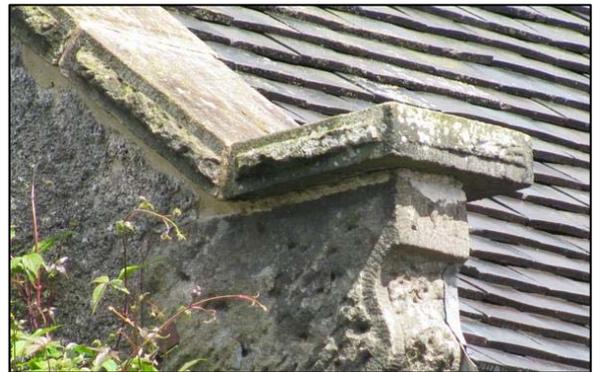
P5.6 Stone coped gable + moulded kneeler at 1 and 2 Rose Cottages

5.30 A characteristic feature of many of the detached eighteenth and nineteenth/early twentieth century buildings is stone coped gables with moulded kneelers. A number of the later nineteenth century properties, including Hawthorn House, South Croft, Church View and The Croft have symmetrical frontages with a central doorway and bracketed canopy above, with sash windows on each side to each floor and gable end chimney stacks. The brackets below the canopy at Hawthorn House are particularly decorative. A number of the smaller, terraced nineteenth century properties also have bracketed canopies above front doors.

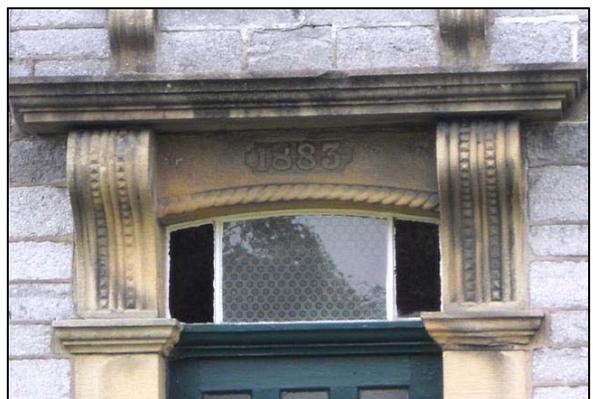
P5.7 Decorative brackets at Hawthorn House

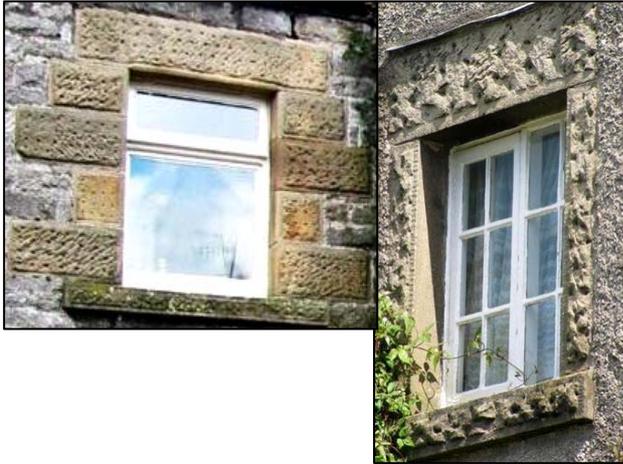
5.31 A picked tool finish to quoins and window surrounds is a nineteenth century/early twentieth century detail commonly found in Monyash.

P5.8 Examples of picked tool finish

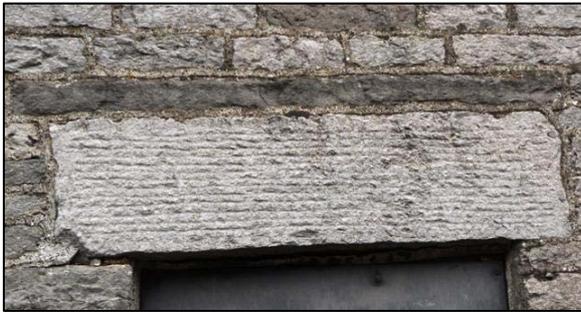
5.32 Some of the limestone lintels and surrounds display horizontal tooling, which is unusual as limestone, being a particularly hard stone, is rarely dressed.

P5.9 Horizontal tooling to limestone lintel

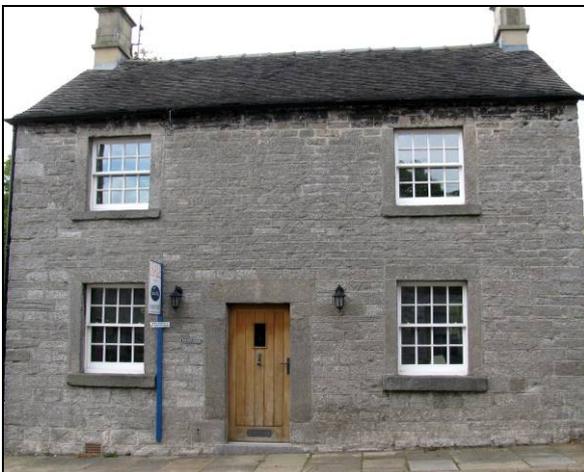
P5.10 Early-mid C19th windows at Bolton House

5.33 In the first half of the nineteenth century windows had smaller panes and the sashes had no horns, as can be seen at Bolton House on Chapel Street. Horns were introduced when panes of glass increased in size from around 1860 onwards. The later windows typically had two panes of glass in each half sash and detailing to surrounds became more ornate, such as the decorative lintels to the frontages of South Croft and Hawthorn House.

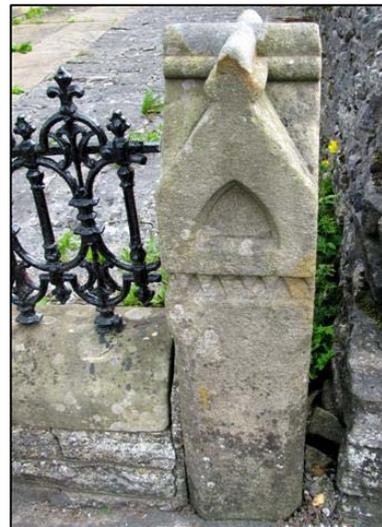
P5.11 Gate post + railings at Methodist Chapel

5.36 The Primitive Methodist Chapel, erected in 1888, displays features typical of mid-late Victorian gothic architecture, and has ornate railings above the boundary wall, with decorative stone gate-posts.

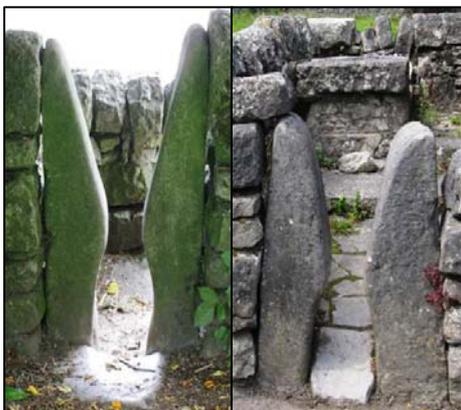
P5.12 Squeezer stiles

5.40 There are three curved squeezer stiles within the Conservation Area which have a similar form and which are of historical interest. These are at the north-east entrance to the churchyard on Church Street, at the entrance to the enclosure containing the stone trough and telephone box on Chapel Street and within the front boundary wall at the entrance to Mere Farmhouse, on Rakes Road. The simpler, flat-stone squeezer stile at the western entrance to the mere on Rakes Road is also of historical interest.

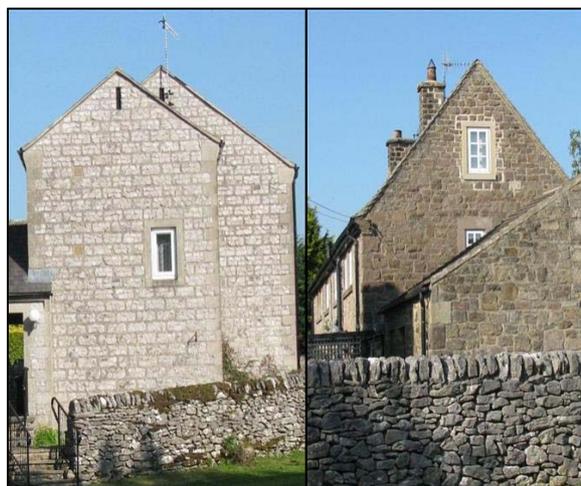
P5.13 Non-traditional roof pitches at The Orchard

5.43 The other twentieth century buildings at The Orchard are also non-traditional in design, some having a very shallow roof for the height of the building and others having very steeply pitched roofs. In general, however, the size and scale of these properties are in keeping with the more traditional properties within the village and the buildings are clustered into one relatively small area, surrounded by traditional stone boundary walls. As a result, their impact on the character and appearance of the Conservation Area is minimal.

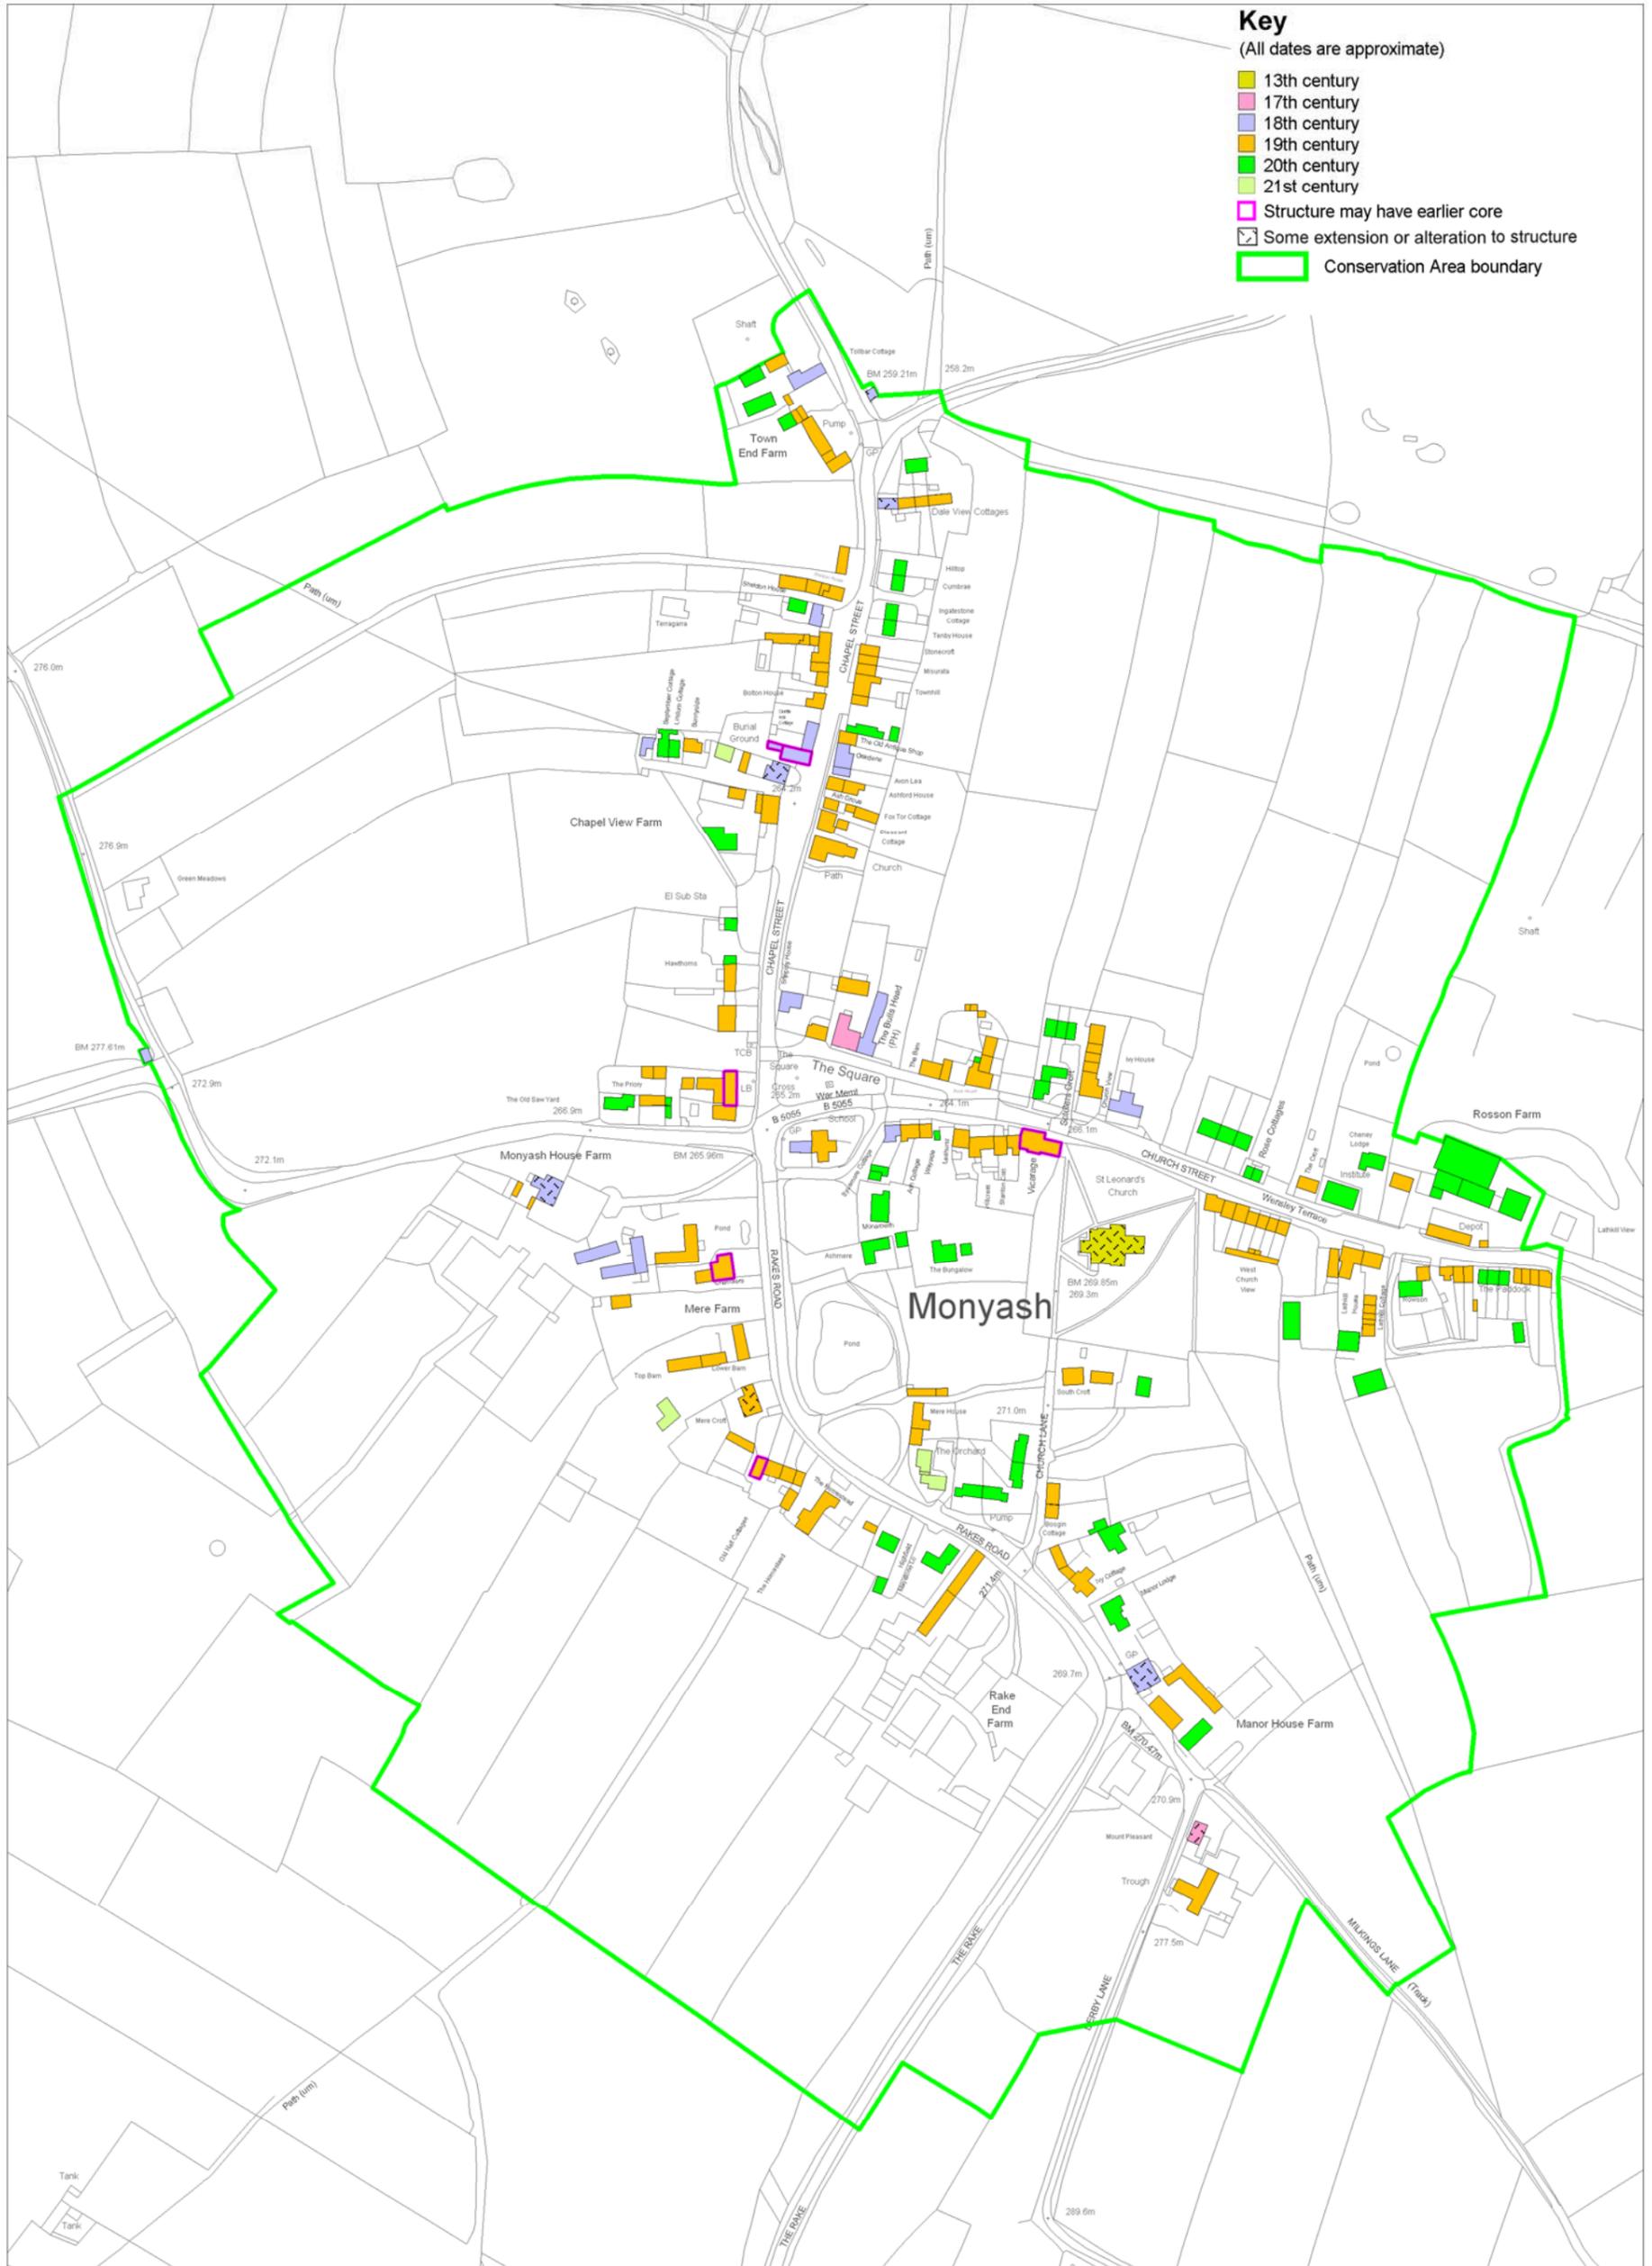
(All dates are approximate)

Fig. 10. Architectural Development within Monyash Conservation Area

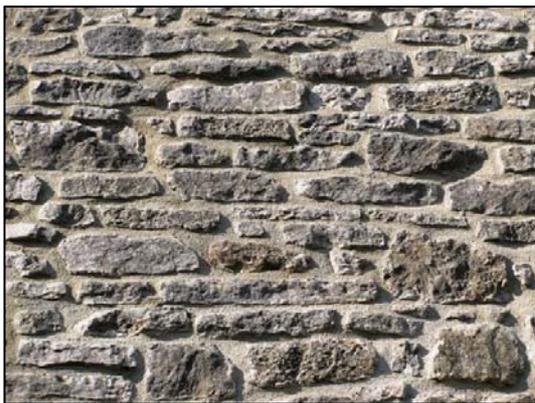
P6.1 Rubble limestone walling

6.2 Buildings in Monyash traditionally have limestone walls, either coursed, roughly dressed squared limestone or rubble limestone brought to courses. A few buildings, such as some of the barns to the east of Monyash House Farm and to the rear of Manor House Farm, have random rubble limestone to the side walls. Other buildings have coursed stonework to the frontages with side and rear walls uncoursed or only roughly coursed.

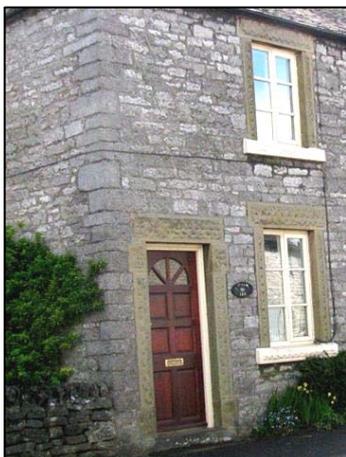
P6.2 5 Church Street, limestone+gritstone dressings

6.3 Most buildings have either gritstone or limestone dressings. Some properties have a mixture of the two, such as 5 Church Street, which has gritstone window and door surrounds and limestone quoins. A number of buildings have gritstone gable coping stones and kneelers.

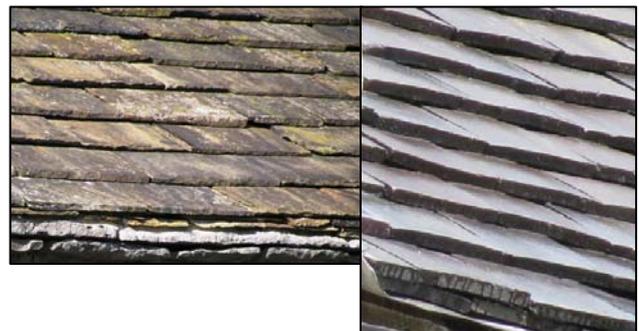
P6.4 Stone slate + Staffordshire blue clay roofs

6.7 Roofs within Monyash are traditionally of stone slate or Staffordshire blue tiles, with blue slate on the later nineteenth century properties. The Methodist Chapel has a mixture of plain and club clay tiles and ornate clay ridge tiles. Concrete Hardrow tiles have replaced traditional roofing materials in places.

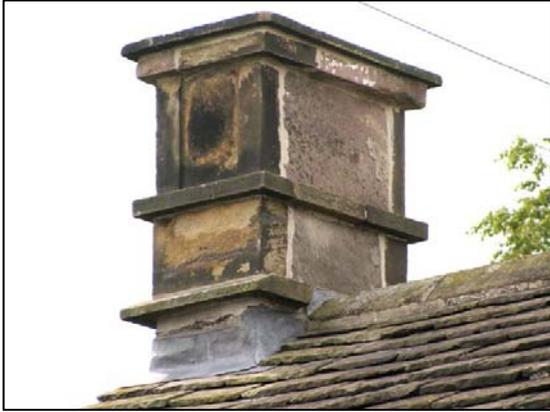
P6.5 Gritstone chimney

6.8 Stone chimneys are a traditional feature within the Conservation Area. Both limestone and gritstone chimneys are found and a number have gritstone copings, bands and drip courses. Blue engineering brick and red brick have been used on some nineteenth century properties and have replaced stone stacks on older buildings in places. Brick generally is an alien material to the Monyash Conservation Area.

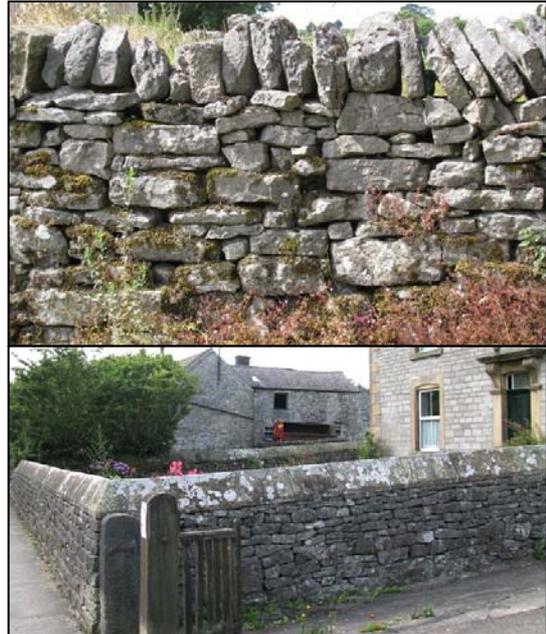
P6.6 Boundary walls

type of walling continues into the medieval crofts in the centre of the village and through much of the built environment within the Conservation Area. Boundary walls to individual properties vary from drystone to mortared limestone rubble, mostly uncoursed although there are some more modern examples of coursed rubble construction. Both vertical flat limestone and rounded limestone copings are found to property boundary walls and there are occasional examples of gritstone copings to more modern walls. Hawthorn House has triangular gritstone copings above a coursed rubble limestone wall.

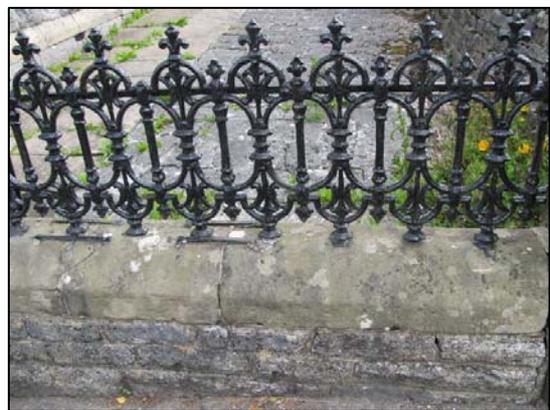
P6.7 Boundary wall+railings to Methodist Chapel

6.14 A few buildings have gritstone gatepiers within their boundary walls, for example at the entrance to the field on the south-east corner of Tagg Lane and Rakes Road. The boundary wall to the Methodist Chapel is distinctive and unique within the Conservation Area, comprising a low limestone wall with heavy gritstone copings and ornate cast iron railings above, with decorative gritstone gate piers. This is the only instance of boundary railings within the Conservation Area.

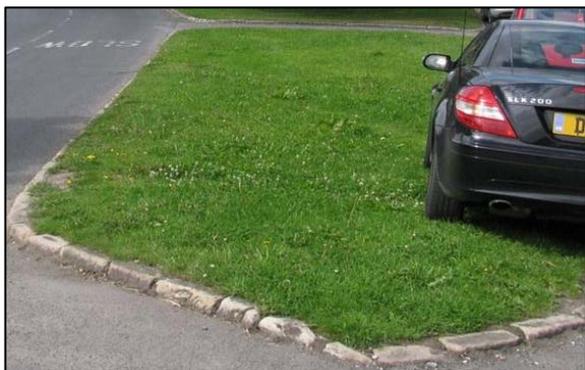
P6.8 Gritstone kerb around the green

tracks, but tarmac is now the predominant surfacing material. There are gritstone kerbs around the edges of the green within The Square, as well as in front of Mere Farm and Old Hall Cottages on Rakes Road.

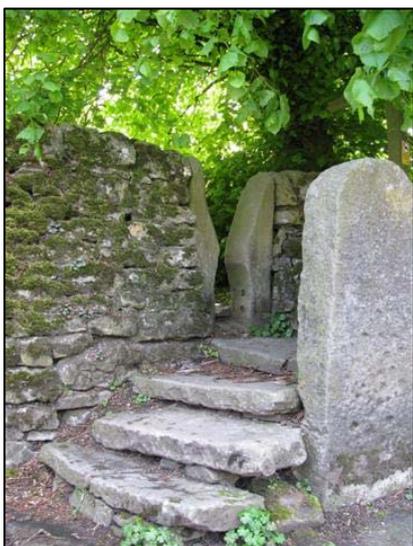
P6.9 Limestone steps at NE entrance to church

6.17 Limestone slabs form steps up to the north-eastern entrance to the churchyard and limestone slabs inset within the southern boundary wall of the churchyard step up to the stile which leads to the path across the field. There are similar limestone slabs forming steps up to the stile at the north-west corner of the car park on Chapel Street, with stone paving slabs in front of the stile, although these have lifted and no longer provide a flat surface. The main pathway through the churchyard has limestone pitchings edged with stone.

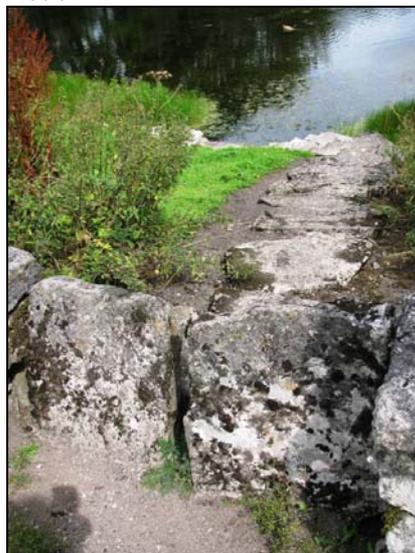
P6.10 Squeezer stile and steps leading to mere

6.19 The mere is roughly edged with limestone boulders, which have fallen into the water in places and there are stone steps leading down to the mere from the squeezer stile on Rakes Road.
