1. Bareleg Moorland Hydrological Restoration Brief

Written by Hazel Crowther (Peak District National Park Authority) and Kate Williams (Natural England)

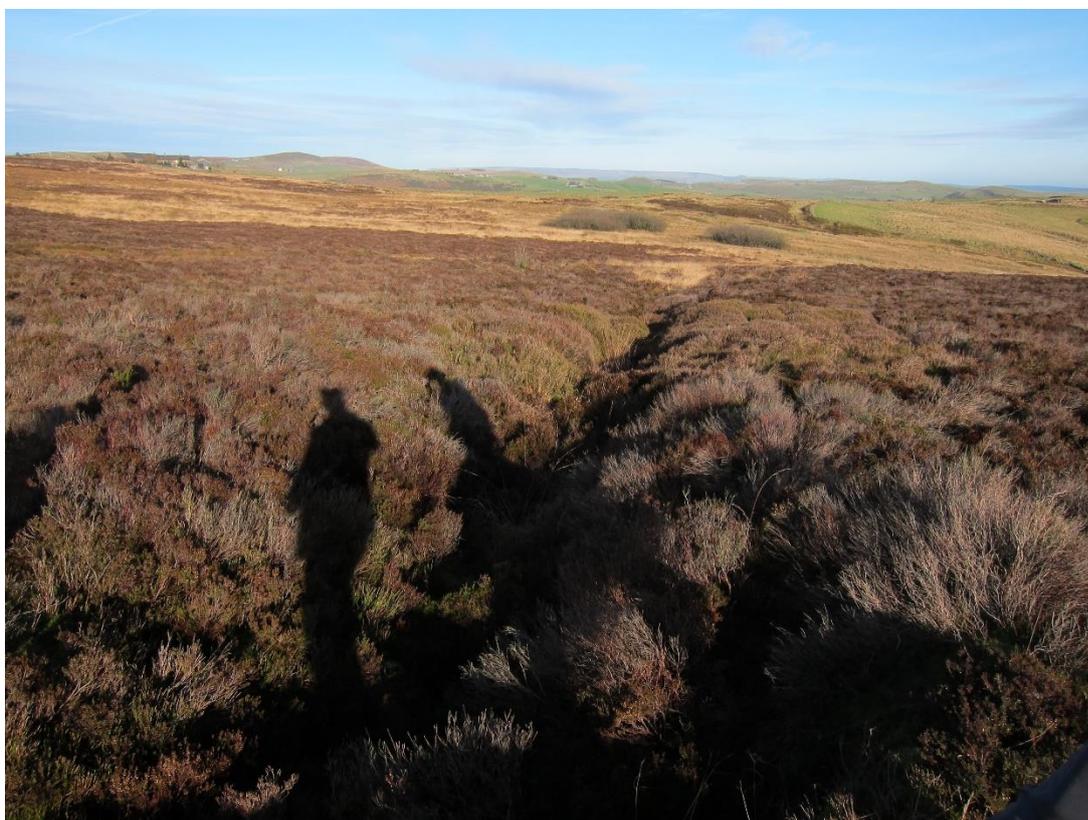
Typical view looking northeastwards across the site showing a drain feature:

Under previous ownership the moorland formed part of a wider shooting estate and a number of natural watercourses were modified to encourage drainage of the moor. Whilst these are limited in extent they continue to have an impact on the hydrological condition of the moor. Generally these have peat bottoms with well vegetated sides. The photograph below shows one of these features. This project seeks to address past drainage and also seeks opportunities to slow the flow of water and enhance the hydrological function of the blanket bog as a whole.
