**Route Summary Report
Riley Lane
March 2018**

Riley Lane commences east of Town End, Eyam and proceeds generally eastwards on tarmac road, then continuing east through Pretty Wood and finally south east to New Road.

Legal Status: BOAT and footpath
County: Derbyshire
Parish: Eyam
Grid Reference: SK224764 to 234759
Length: 1300 metres

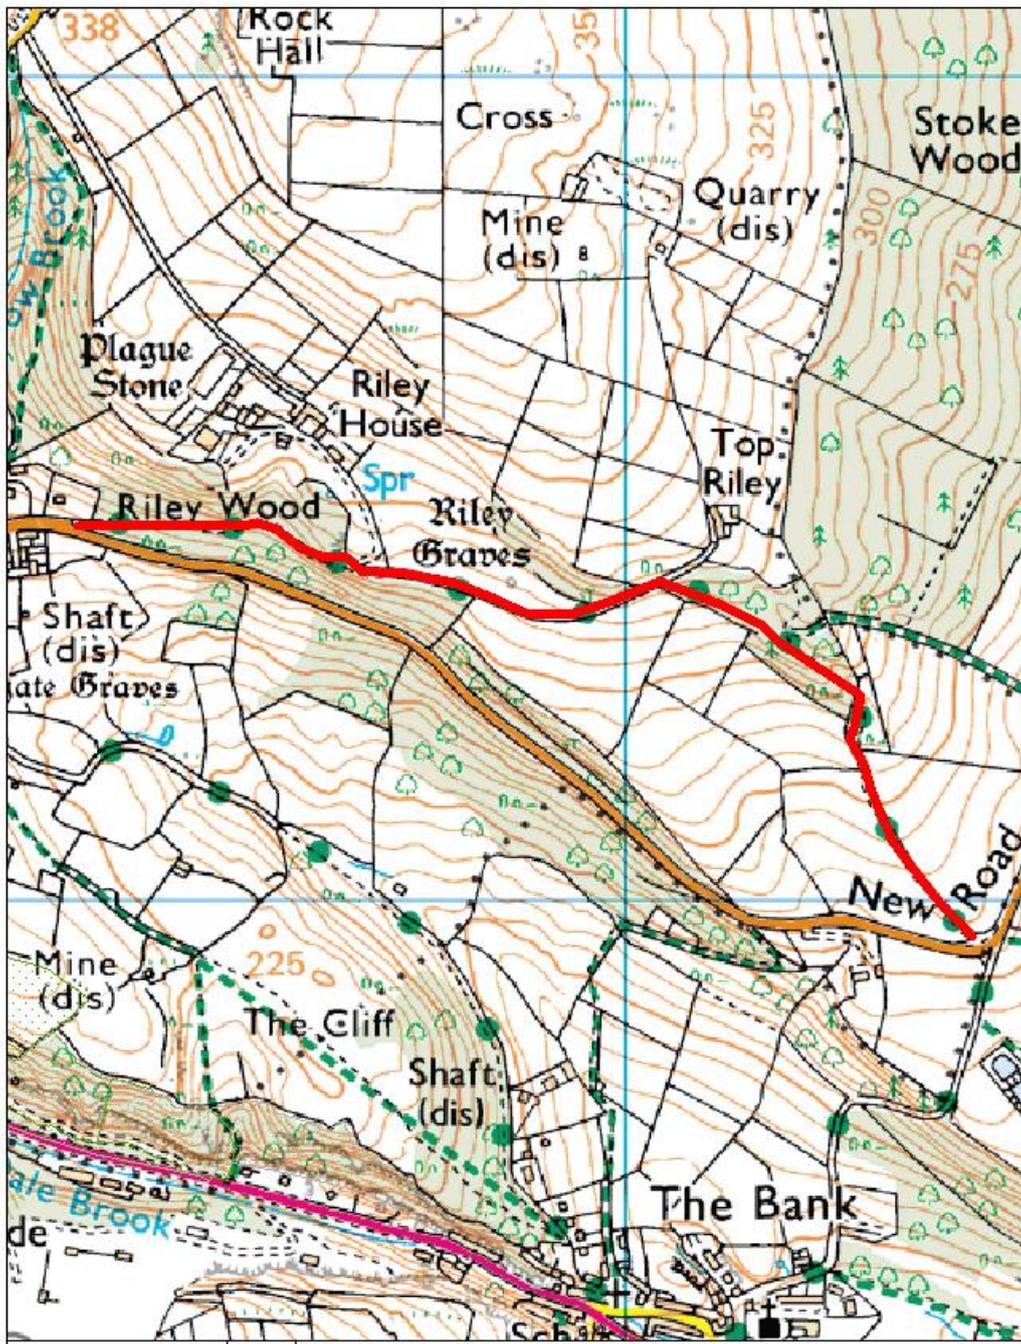
<p>PEAK DISTRICT NATIONAL PARK AUTHORITY</p>	<p>N</p>	<p>Riley Lane</p> <p> Route with proven or possible motor vehicle rights which may be unsustainable</p>	<p>DESIGNATIONS</p> <ul style="list-style-type: none"> Site designated as one or more of <ul style="list-style-type: none"> - Site of Scientific Interest - Special Area of Conservation - Section 3 & Natural Zone Scheduled Ancient Monument
---	----------	--	---
