**Route Summary Report
Clough Wood
March 2018**

Clough Wood commences at Upper Town, south of Birchover and serves as access for properties before continuing eastwards, descending through Cowley Knowl and then continuing east as a tarmac road (referred to as Oldfield Lane) to classified road near Darley Bridge

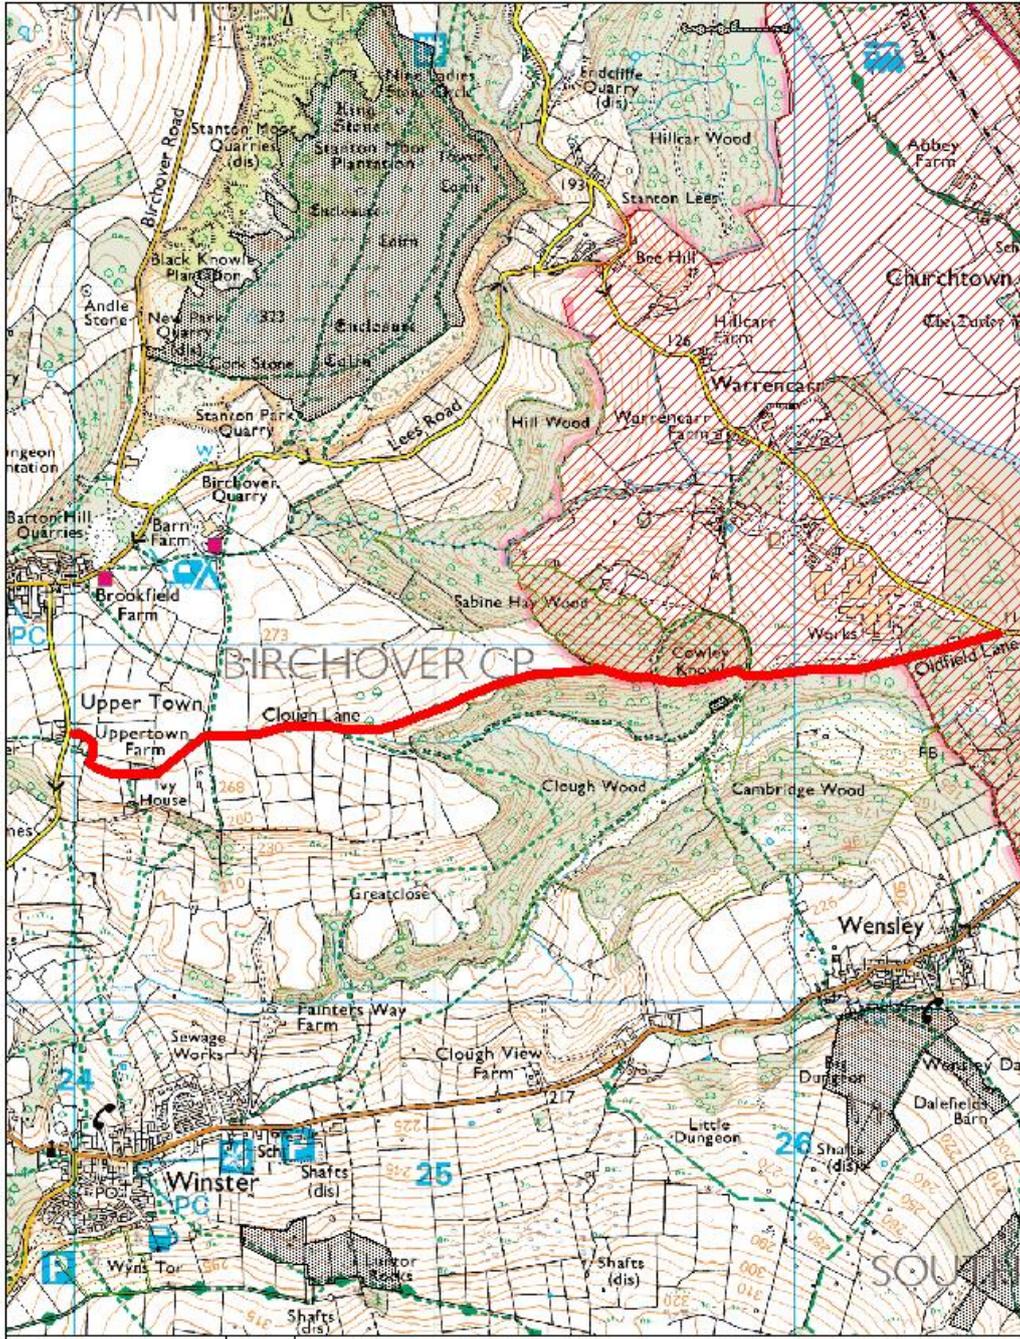
<p>Clough Wood</p> <p> Route with proven or possible motor vehicle rights which may be unsustainable</p>	<p>DESIGNATIONS</p> <ul style="list-style-type: none"> Site designated as one or more of <ul style="list-style-type: none"> - Site of Scientific Interest - Special Area of Conservation - Section 3 & Natural Zone Scheduled Ancient Monument
--	---	---
