**Route Summary Report
Swan & Limer Rakes
March 2018**

Swan and Limer Rakes are integrally linked. Both routes are sunken lanes for the most part, with broken stone surfacing and/or exposed bedrock, which in places is stepped. The routes are currently closed pending repairs by Staffordshire County Council as the Highway Authority.

Legal Status: Non-classified Highway
County: Staffordshire
Parish: Hollinsclough CP
Grid Reference: SK 062 662 to 065 665 and SK 063 664 to 065 659
Length: 420 metres and 610 metres

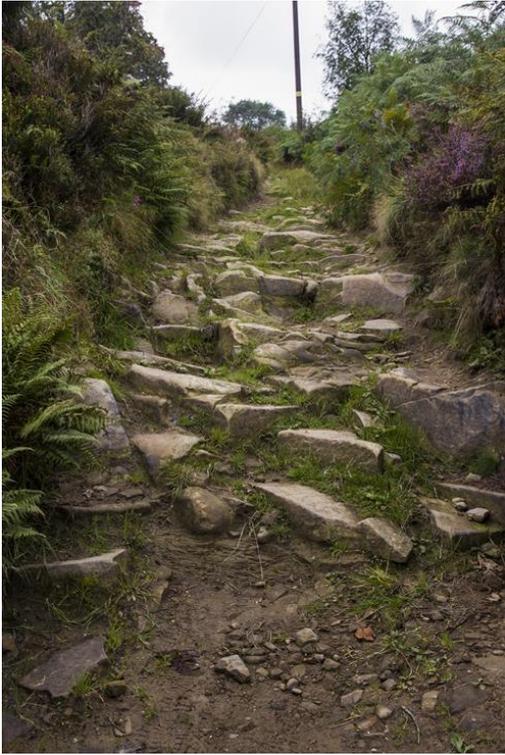
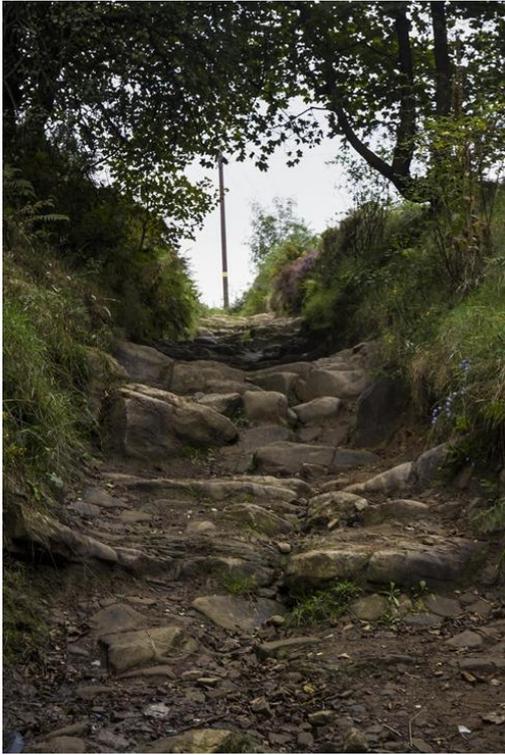
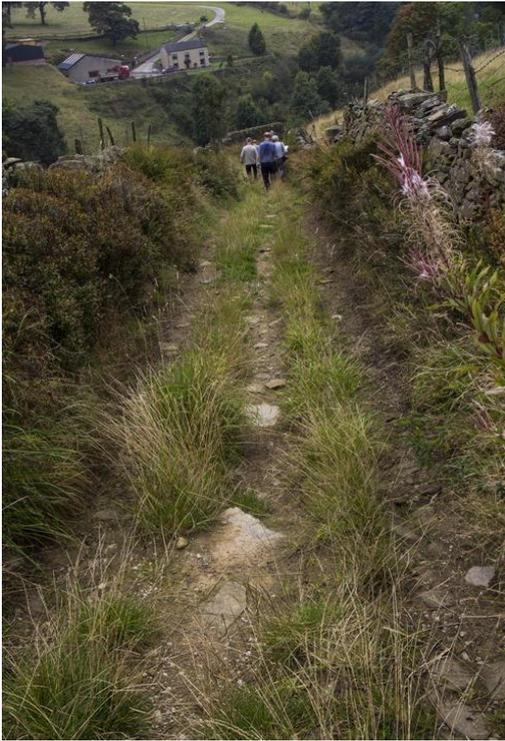
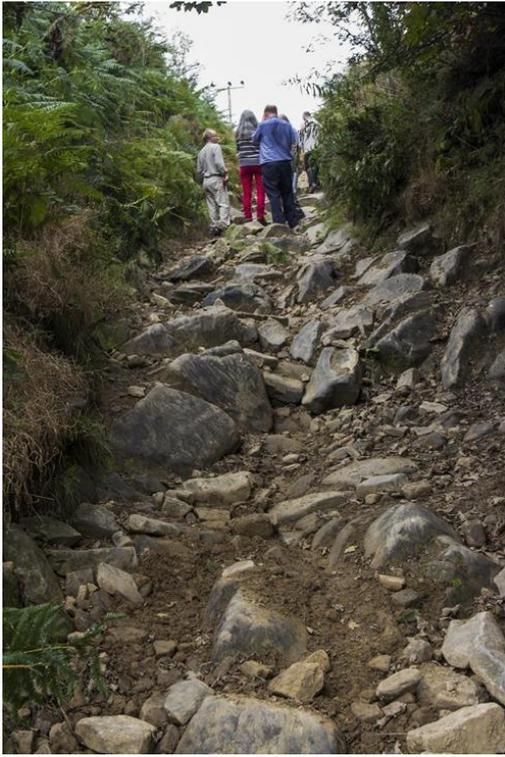
Comment: Parts of both routes are practically impassible for the majority of users, with exposed bedrock steps

The track is severely damaged over a section of 65-70m; it has been eroded down to the bedrock and contains 14 rock steps up to 60-75 cm in height. These appear impassable to 4wd vehicles or very difficult to pass, and similarly difficult for motorcycles (3 motorcyclists attempted to ascend the track during the time of the survey but turned around and went back). Cyclists would most likely be forced to pass this section on foot, too.

The first short section is marked by two ruts to a depth of 10-25 cm. The track then steepens and bends round to the left; this section is rockier and covered in loose stones, and eroded down to the bare rock in places, exposing rock steps that would be difficult to navigate in a vehicle , motorcycle or bicycle. Then a long stretch descends across the slope to the end. Here the bed is generally softer and rutted along most of its length, with ruts of 20-30 cm and reaching 50 cm over one short section.
