**Route Summary Report
Pin Dale
March 2018**

Pin Dale is a steep, rocky and eroded way which passes through a disused quarry, parts of which are a Site of Special Scientific Interest and a Scheduled Monument. Boulders, fencing and signage have been placed at the side of the track to limit deviation onto the adjacent SSSI land.

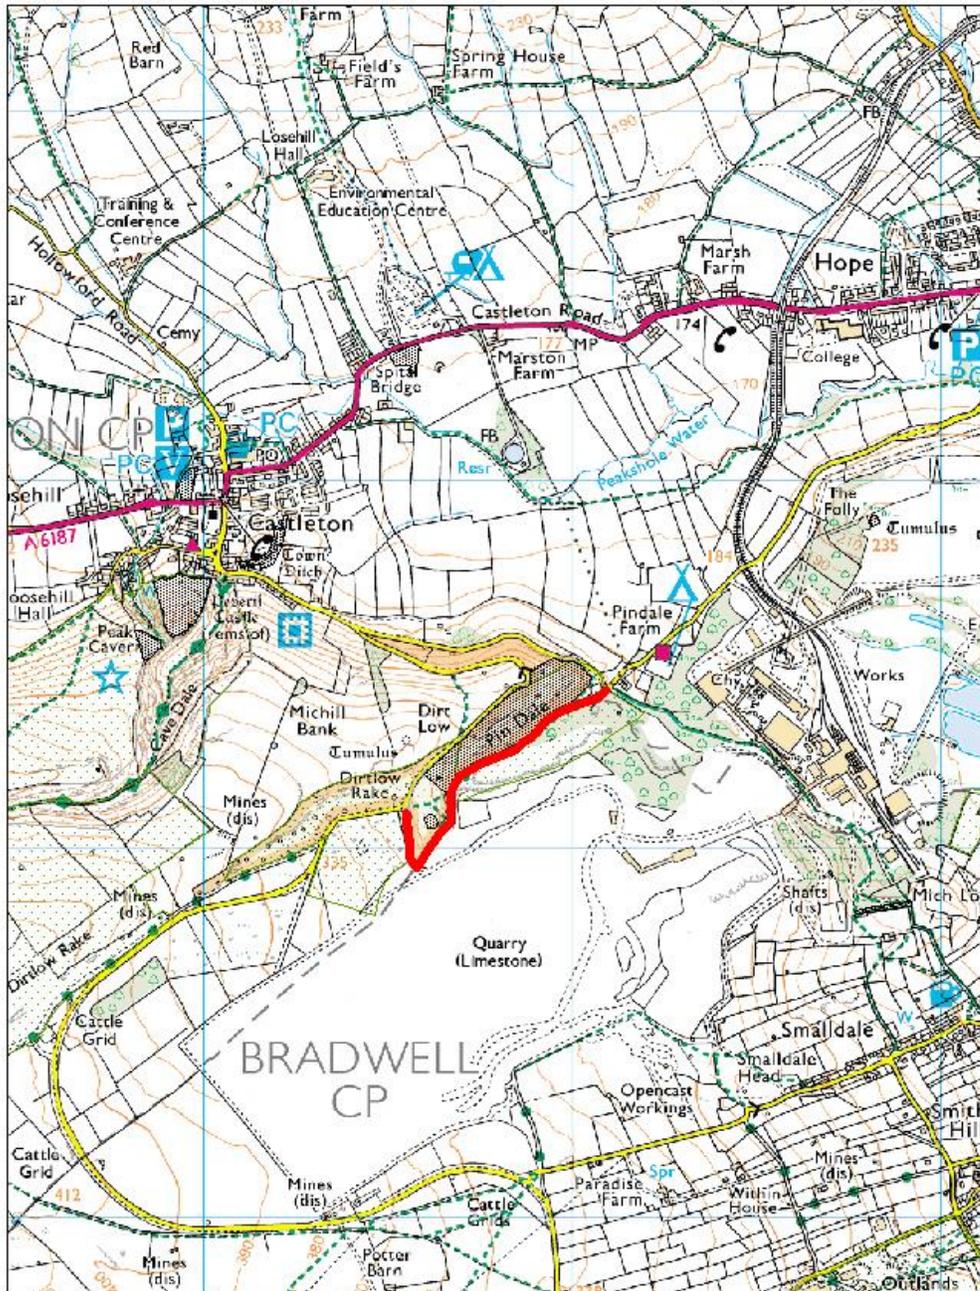
<p>PEAK DISTRICT NATIONAL PARK AUTHORITY</p>	<p>Pin Dale</p> <p> Route with proven or possible motor vehicle rights which may be unsustainable</p>	<p>DESIGNATIONS</p> <ul style="list-style-type: none"> Site designated as one or more of <ul style="list-style-type: none"> - Site of Scientific Interest - Special Area of Conservation - Section 3 & Natural Zone Scheduled Ancient Monument
---	--	---
