# Moorlands Lane

## Route Management Plan

# Moorlands Lane - Route Management Plan

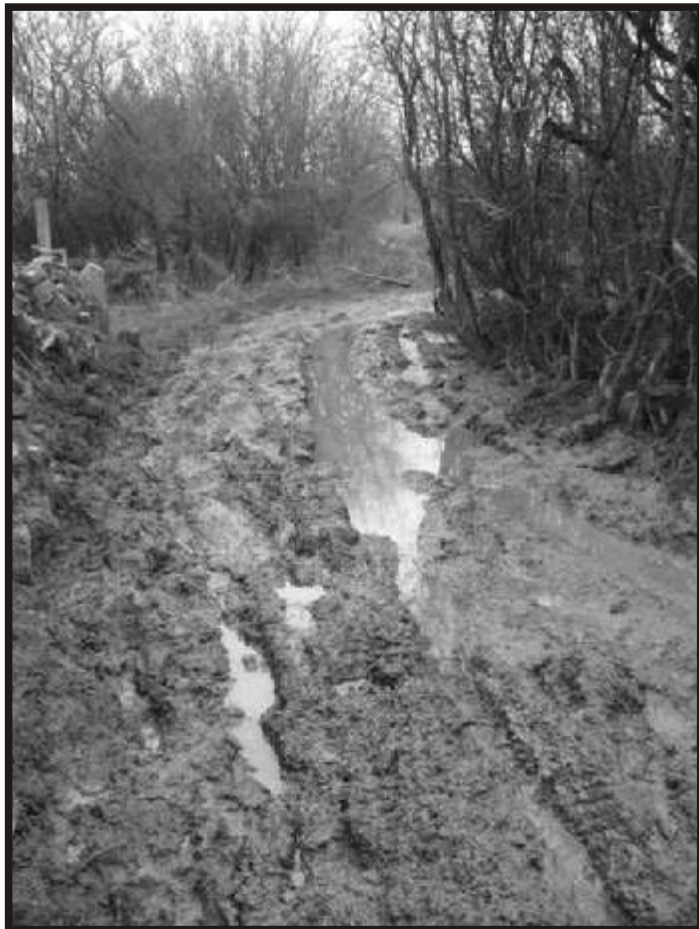
Moorlands Lane

Links into several NCHs and claimed Byways in the area of Bonsall Moor Quarry.
