Shatton Lane

Route Management Plan

Shatton Lane - Route Management Plan

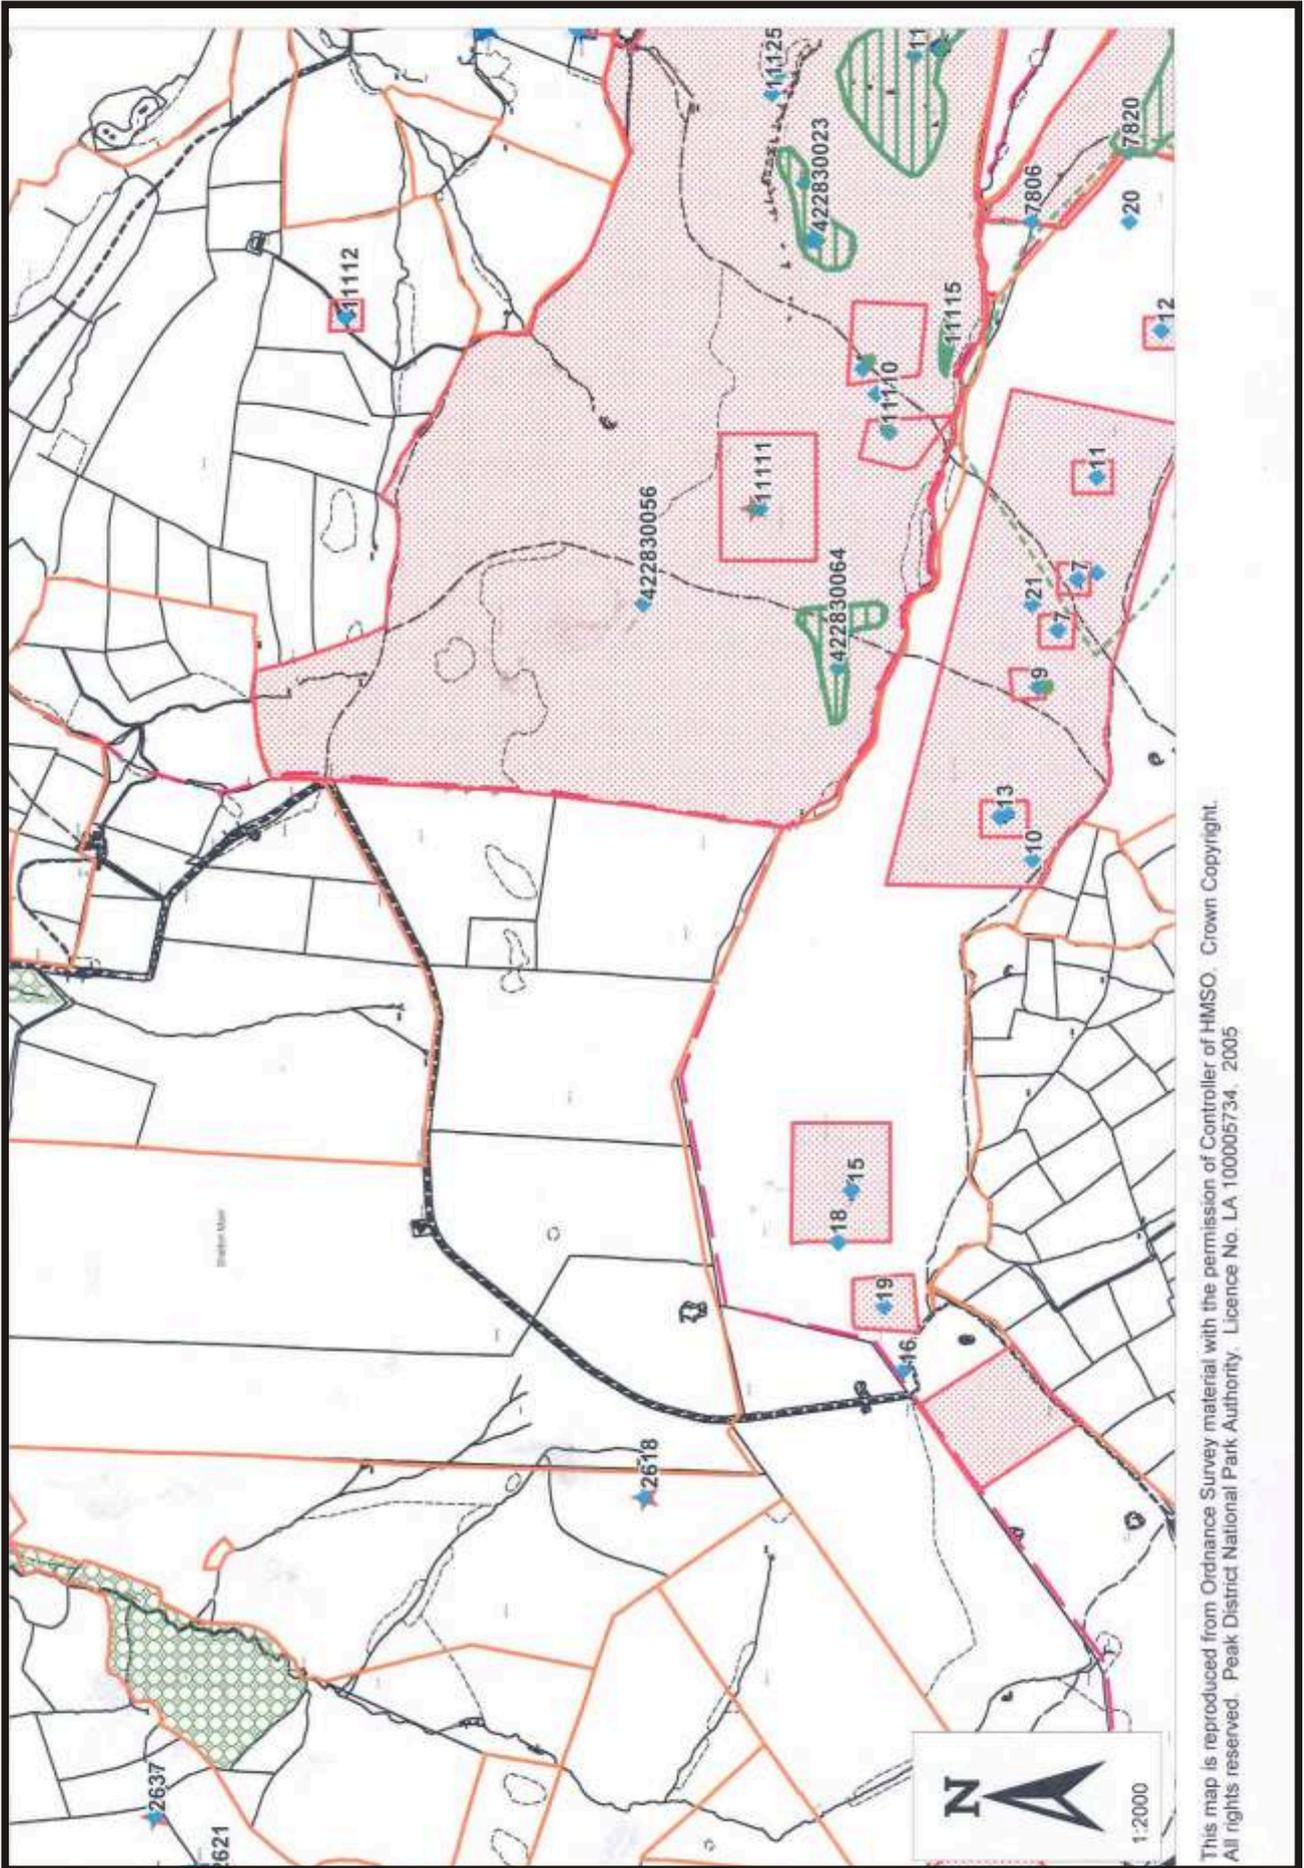
Map illustrating Cultural Heritage Features on or close to the route

Historic landscape character information: the route runs through land which is characterised as Post-1650 Encl - Parliamentary Enclosure Award. Allotted and enclosed as shown on the Brough & Shatton Enclosure Map of 1850.
